Skid-Steer Rock Saw Modification

**BAE 4022
Senior Design
May 04, 2007**

Redesign of Skid-Steer Mounted Rock Saw

**Biosystems & Agricultural Engineering Department
Oklahoma State University**

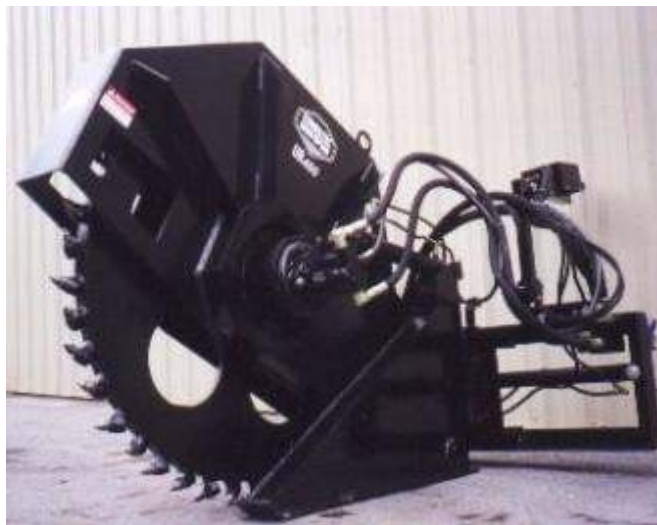
CONEQTEC Universal of Wichita, Kansas manufactures attachments for skid-steer loaders to substitute for the standard bucket attachment. One of their attachments is a rock saw which is used to cut non-reinforced concrete and asphalt as well as other pavement surfaces. CONEQTEC's production model of the rock saw is axially driven by a hydraulic motor through a planetary gear set which limits the depth of cut to about 35% of the blade diameter which is slightly less than the radius of the blade.

Figure 2: Production Model Rock Saw (CONEQTEC 1)

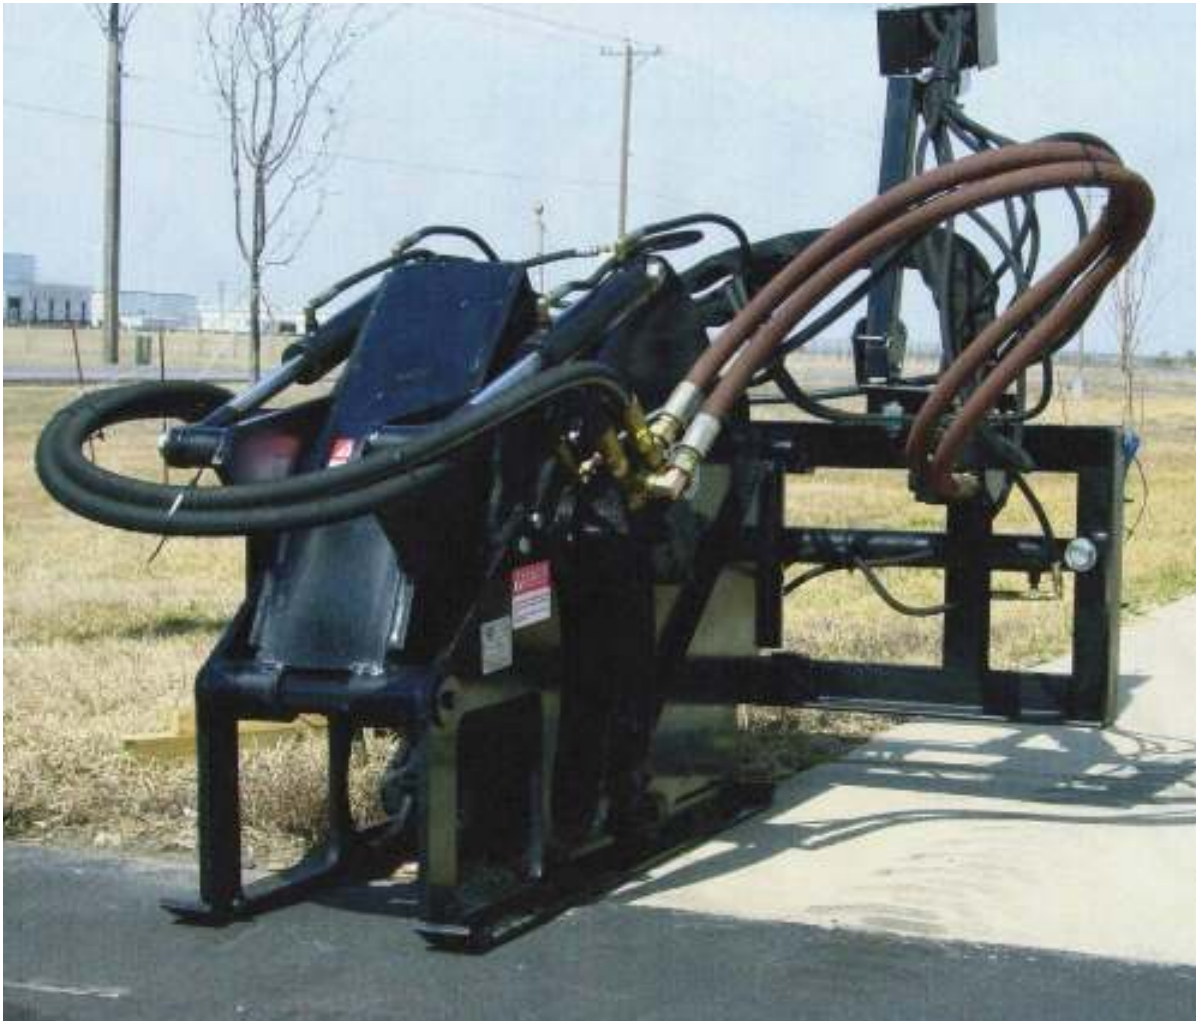
Figure 3: CONEQTEC Prototype

Ring gear teeth were mounted directly to each face near the perimeter of the wheel. The pinion gear was composed of 5 free-turning cylindrical teeth attached to a disk.

Therefore, if both the CONEQTEC prototype and the production model had the same blade size, the prototype would have a 20% deeper depth of cut.

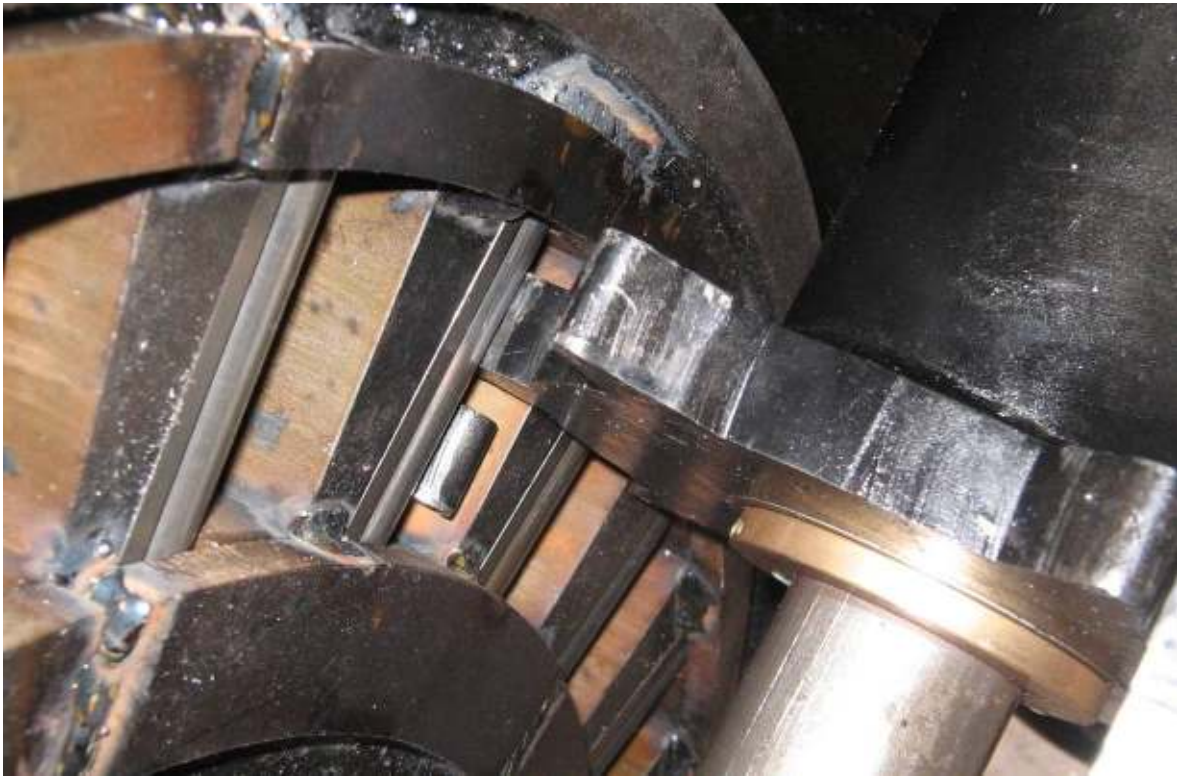
Figure 14: View of BDM's Prototype Gear Mesh

These gears were attached to the hydraulic motors with cylindrical shafts. In order to drive the pinion gears in this configuration, the motors were mounted above the wheel.

This power is transferred from the hydraulic motors with acme gears meshing into the gear holes on the saw blade. The pinion gear teeth apply 450 lbs of force to the replaceable ¾ inch round stock. The gear ratio is 30 driving holes to 7 gear teeth making it 4.3:1. The motors apply approximately 89 hp as well as 2,914 ft-lbs of torque at the picks at 75 rpm. In a wheel made from A36 mild steel with an ultimate strength of 140 ksi, the 1.57 inch minimum spacing between gear holes and 1.0 inch width base of the pinion gear teeth will withstand the maximum possible forces. The shear force experienced between the gear holes is 1000 psi. The shear force experienced at the base of the

pinion gear teeth is 300 psi. Both of these values are considerably less than the fatigue load strength of 41,000 psi, therefore, preventing failure.

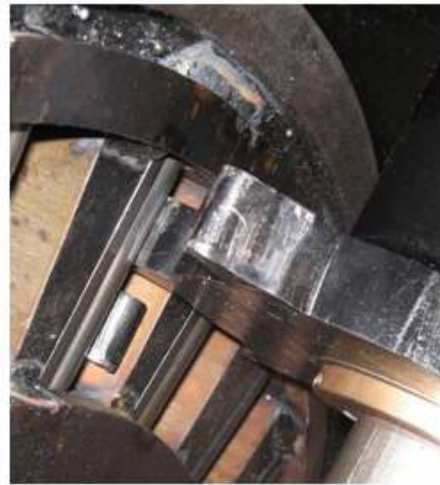
Bottom Gear

- Dedendum circle diameter (D): 5.76"
- Addendum circle diameter (A): 7.62"

Figure 16: Pinion Gear Specifications

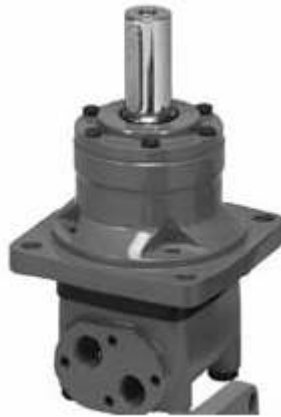
Figure 18: OMT Wheel Mount Flange Motor (Sauer Danfoss 1)

In order to reduce cost, BDM recommends the use of different motors. The current motors can be replaced with motors that have the wheel mount flange housing. The wheel mount flange motors are the same as the current motors with an alternative mounting location.

Instituting this type of motor will make the pinion gears easier to replace and will make the gear retainer parts obsolete. BDM also recommends that an x-y-z adjustable motor mounting system be developed. The combination of using the alternative motors and the adjustable motor mounts may eliminate the costly production of the gear shafts as well as ease the assembly process. BDM would also like to recommend some alternative manufacturing methods. The ear cylinder and plate2 should be one part. The pivot boss inner should be increased to 13 ¼ inches to allow for welding. This part should also have a piece removed from its middle to allow for lubrication.

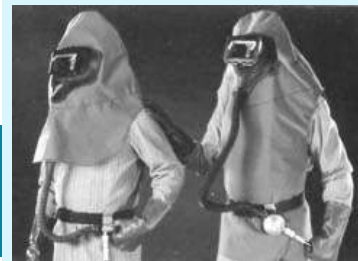
Photo 7

Type CE abrasive-blasting respirator (SAR), operated in a pressure demand or other positive pressure

- Take health (or lung screening) programs offered by your employer.
- Sandblasting or abrasive blasting requires the highest level of protection, which is a type CE abrasive blasting respirator ([see photo 7](#)).

- The amount of silica dust to which you are exposed, and
- The kind of work you need to do.
- If you must do abrasive blasting, use only a type CE pressure demand abrasive blasting respirator (see photo 7).

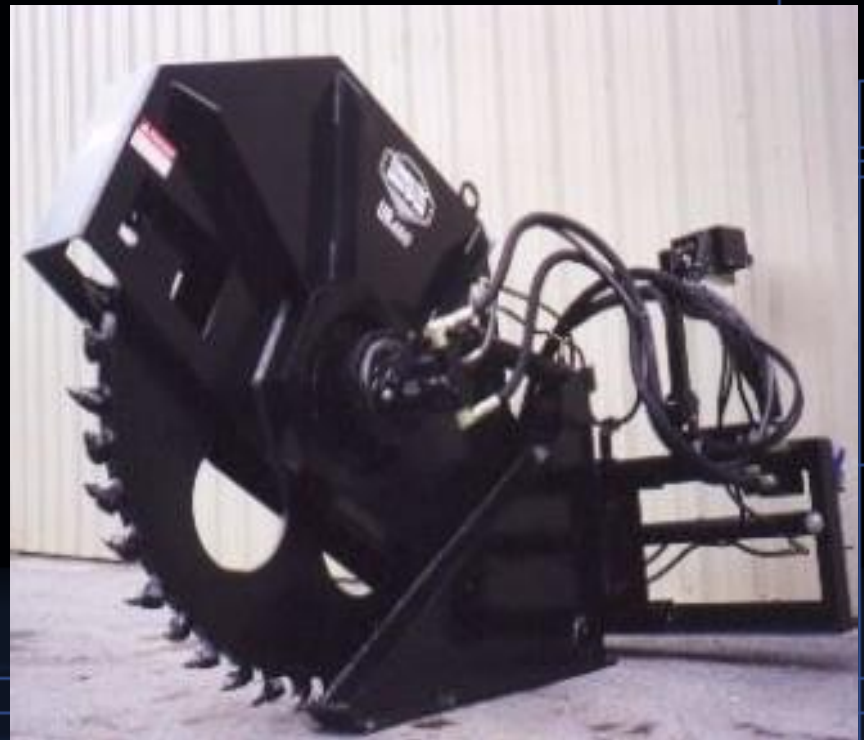
Production Model

- Cutting depth is less than the wheel radius
- To increase depth of cut, the diameter of the blade must increase, therefore, increasing the overall dimensions and weight of the attachment

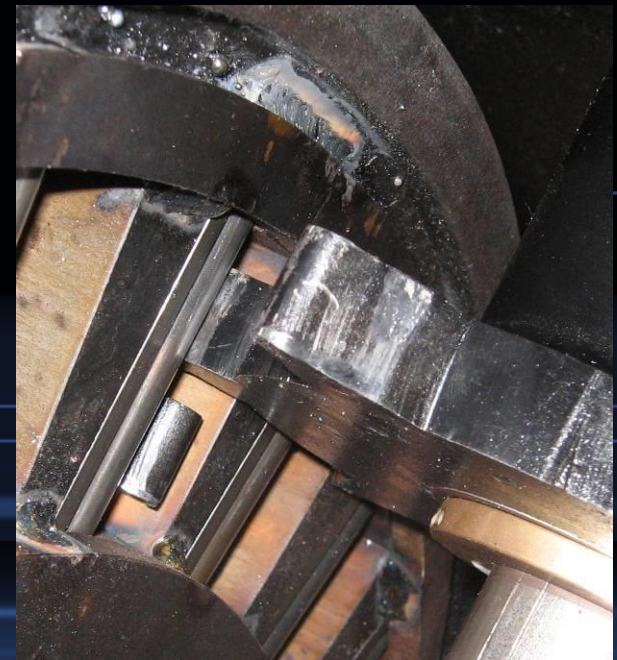
Wheel and Gear Specifications

- 2 Gears – 7 teeth
- 3/4" thick steel
- 1/4" spacing between gears
- Top Gear
 - Dedendum circle diameter (D): 6.16"
 - Addendum circle diameter (A): 8.08"
- Bottom Gear
 - Dedendum circle diameter (D): 5.76"
 - Addendum circle diameter (A): 7.62"

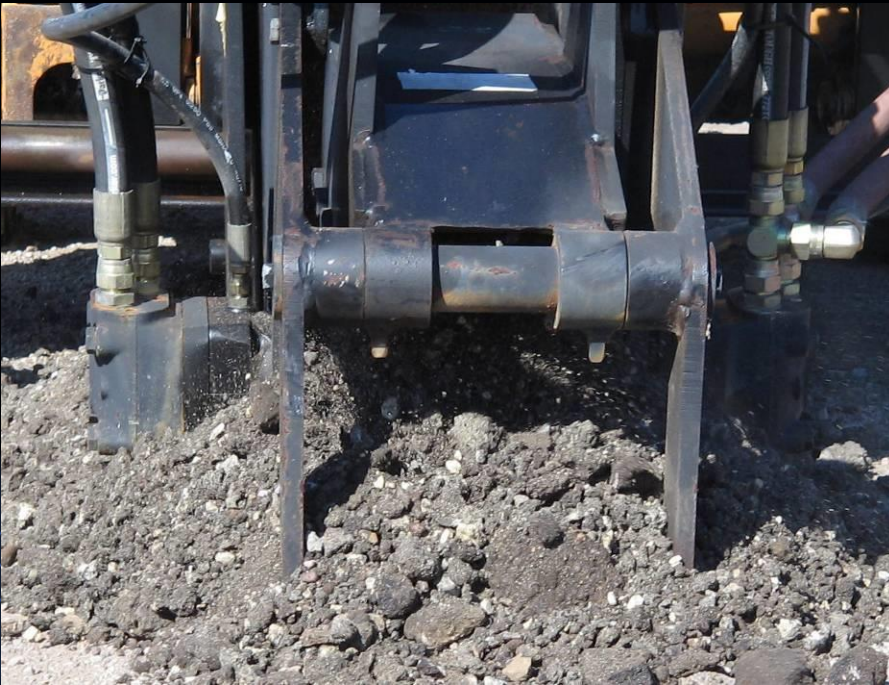
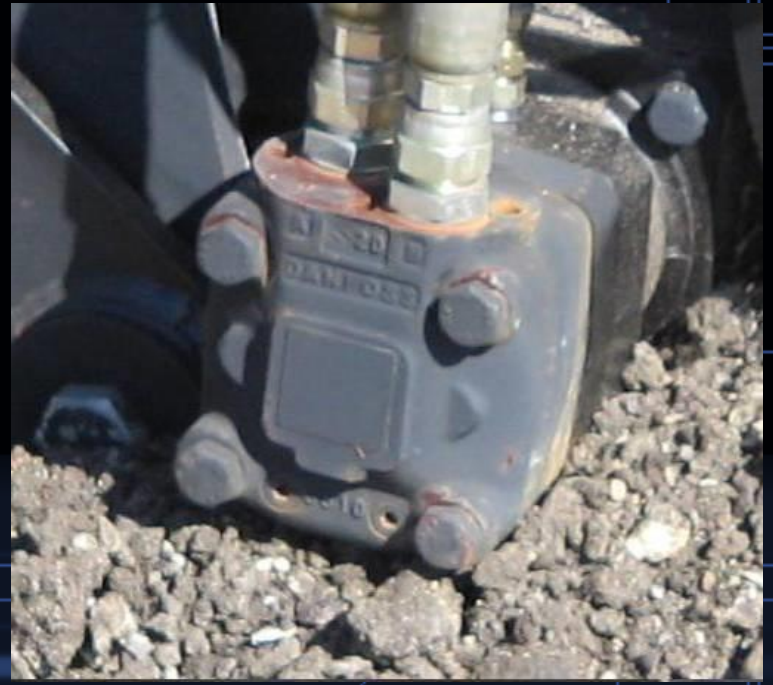
Motor Repositioning

Rotate motors into a vertical position by mounting above the wheel.

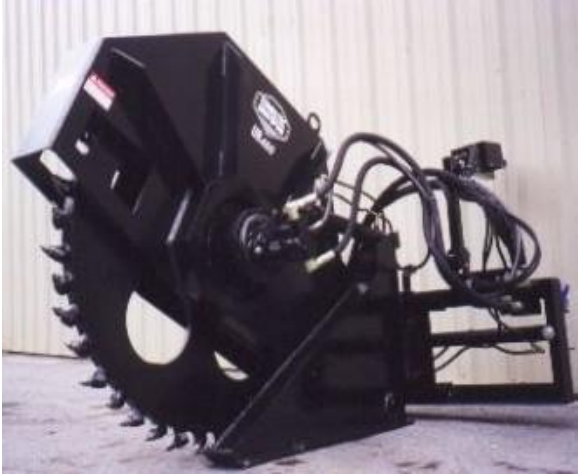
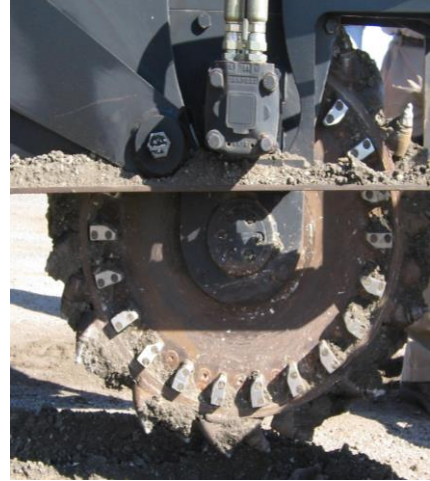
Figure 1: Left- The production rock saw. Right- the prototype rock saw.

CONEQTEC Universal, of Wichita, Kansas, manufactures attachments for skid-steer loaders to substitute for the standard bucket attachment. CONEQTEC Universal has recently redesigned their existing rock saw to achieve a deeper cut via a ring and pinion drive mechanism powered by a hydraulic motor in order to reduce the size of the cutting blade. This project was suspended when CONEQTEC Universal observed that the new design does not have the same useful life as the original, larger diameter design driven by a center mounted hydraulic motor.

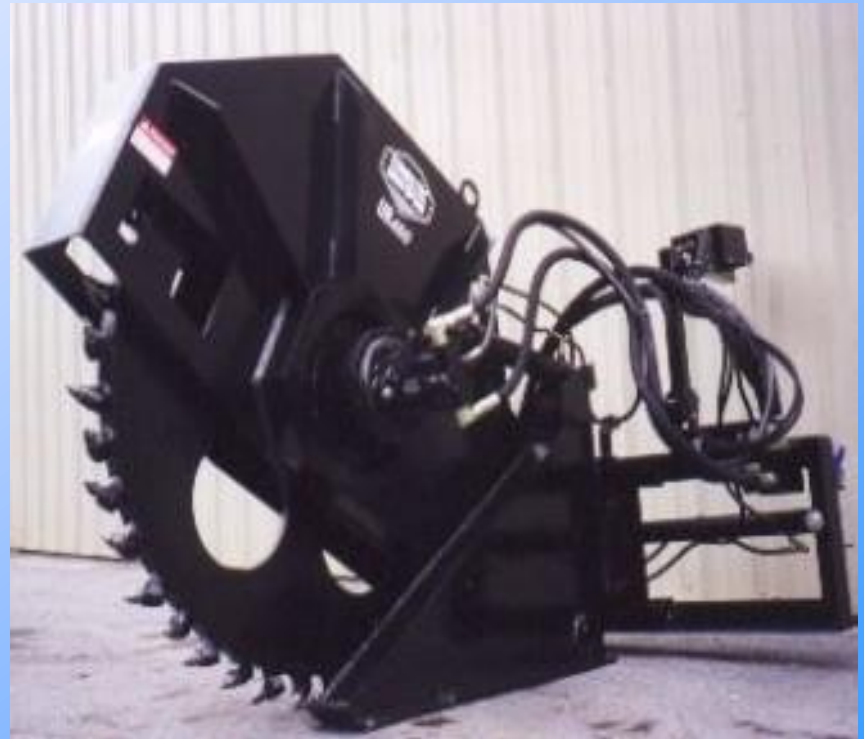
Production Model

- Minimal cutting depth
- To increase depth of cut, the diameter of the blade must increase, therefore, increasing the weight of the attachment.

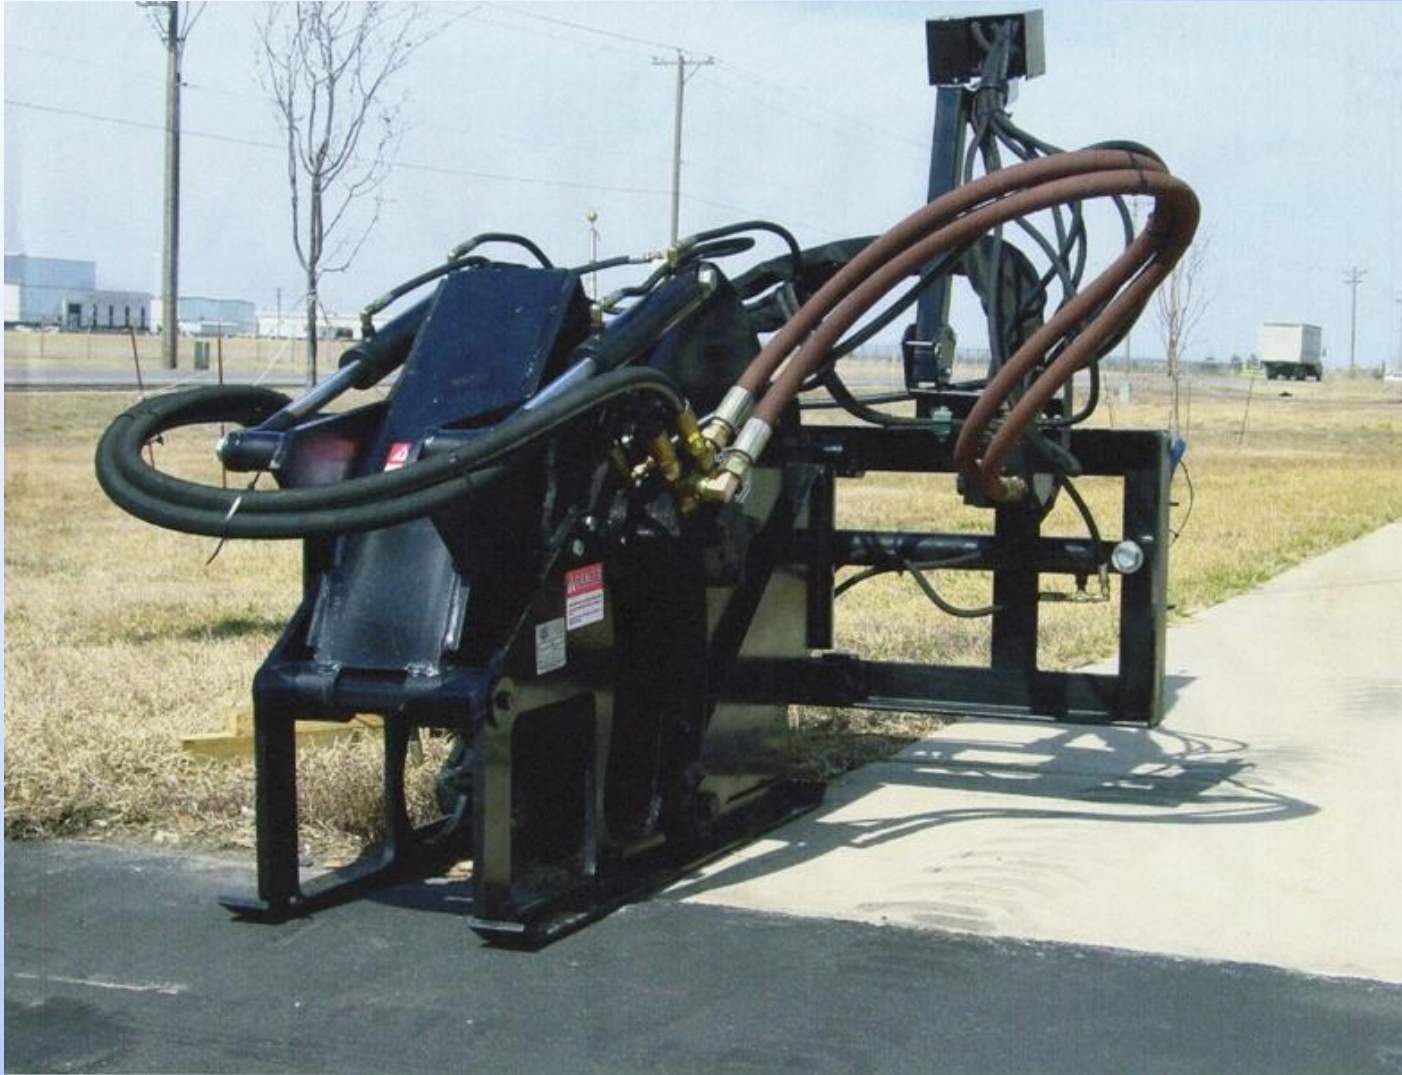
Rock Saw Prototype

- Depth of cut is close to blade diameter
 - 18 inches deep. 2.5 inches wide
- Powered by hi-flow hydraulic system
 - 40 hp input to hydraulic motors
- Laterally adjustable
- CONEQTEC patented design

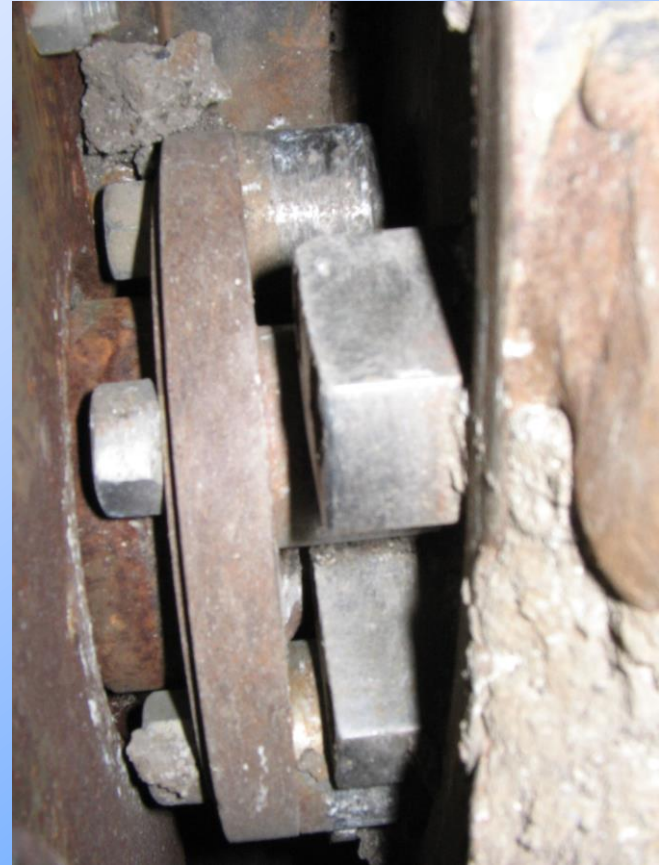
The longevity problem of the rock saw is due to wear on the gear teeth attached to the saw blade.

- Redesign gear mesh
- Increase wearability of gear teeth
