# COWBOY STORMWATER MANAGEMENT

## Senior Design Spring 2017 Report

May 4th, 2017

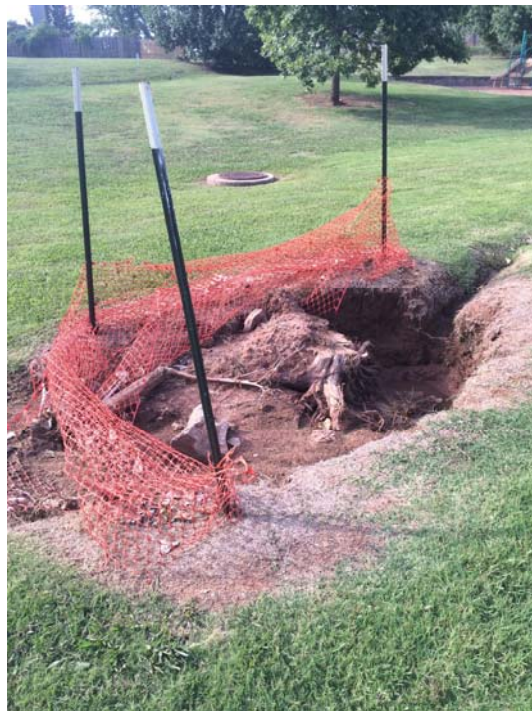
Figure 3. Erosion around Stump

de-sac drainage areas and the stream. There are several small, but severe, erosion sites in the greenbelt area. The outlet for the drain from 304 E. Marie has caused erosion resulting in a large hole. Also, in Figure 3 below, the area around a stump has been heavily eroded causing a large hole that is potentially hazardous.

There are also some areas in the greenbelt that will need to be rehabilitated due to severe erosion. One of these spots, seen in Figure 14, must have the stump and rocks removed. Soil removed for the construction of the channel can be used to fill in this area. It must also be graded to the shape of the current waterway. After this, it must be covered with bermuda sod. The same solution applies for the other eroded spots in the greenbelt area.

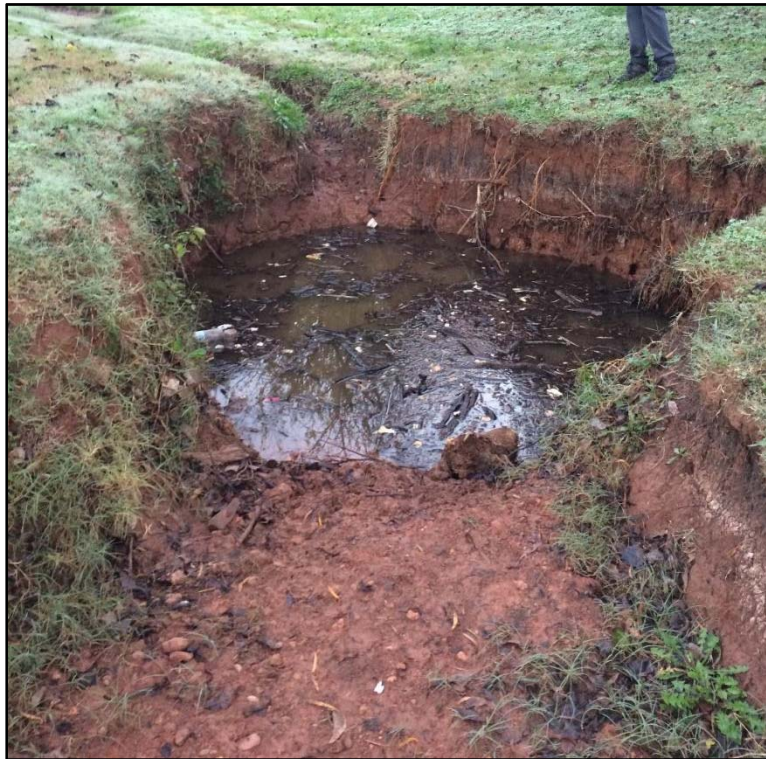
Figure 4. Erosion at Site B

Problem Site B is the entire stream that flows through the neighborhood. It has a total length of 1700ft. This stream is non-perennial as it only flows after rainfall events. With the large amount of runoff mentioned above, all of the water is being guided directly to the stream leading to erosion along the stream banks, as seen in Figure 4 and Figure 5 below. The erosion is responsible for several problems, such as large pools in the stream and sediment deposits, as well as sediment transport to Boomer Lake (Appendix D).

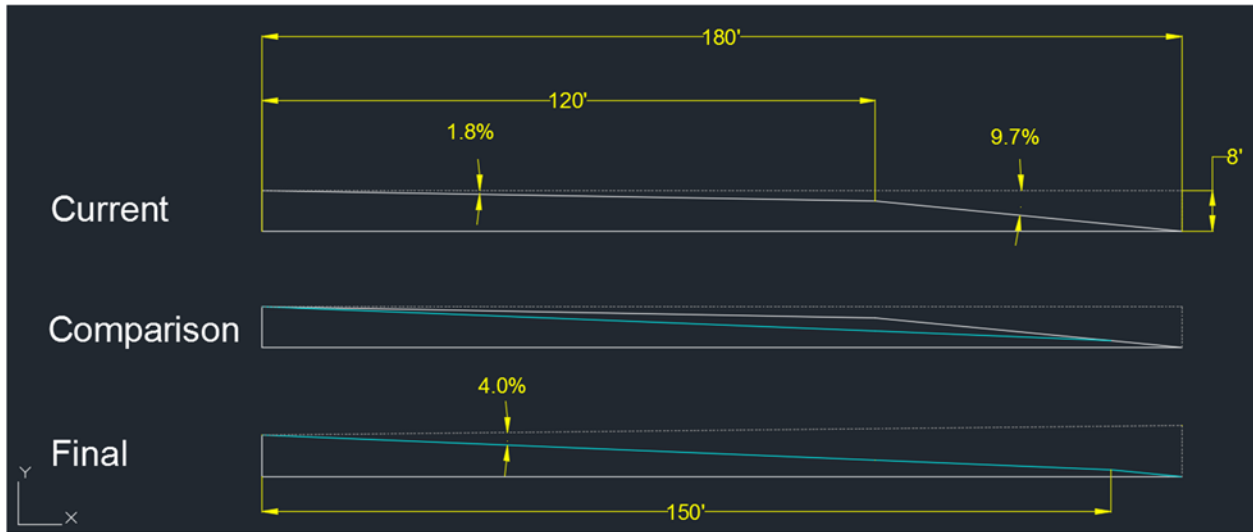
Figure 10. Site A Slope Comparison

The design for this area is to partially regrade the middle of the swale. We want to have a 4% slope with for a 12ft wide channel that is parabolic in shape. This channel will continue until it reaches the hill in the greenbelt area. The total channel length will be approximately 150ft with a 30ft length hill as the outlet. Figure 10 shows the comparison of slopes between the original swale and the final design.

The main issue in this area is ponding in the cul-de-sac after storm events are over. The water is supposed to flow towards the greenbelt area but is not able to do so due to the poor slope of the grass swale outlet. The current slope is at 1.8%. CSM suggests to regrade the grass swale to a more appropriate slope that will allow the water to leave the cul-de-sac without ponding. The current swale, up to about 120ft, is shaped parabolically. The houses on either side are raised in order to protect them from floods.

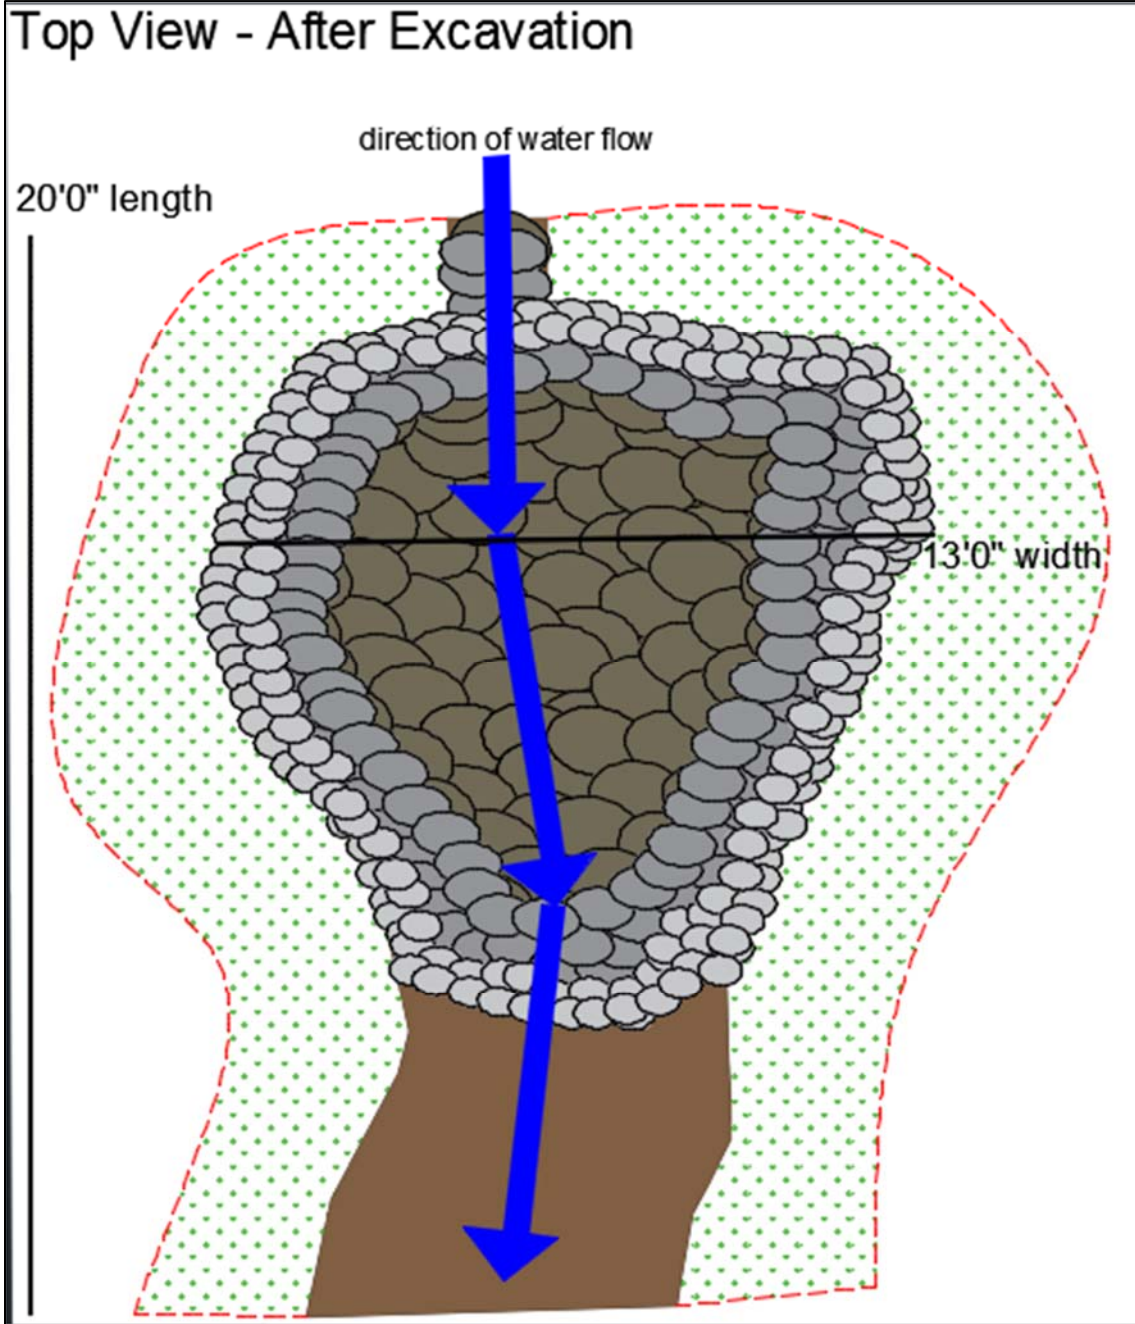
A bank slope of 45% is suggested for the reshaping design at the affected areas. The method used is from a field guide on gully prevention and control that is based on the depth of the stream at the erosion site. A distance of  $\frac{2}{3}$  the depth of the stream will be reshaped along the stream bank to the suggested slope (Desta, 2012). The average depths of the affected areas along the stream range between 3-4ft. However, in more extreme cases the stream may have depths of more than 6ft in some locations, with steep banks. A diagram of the reshaping method can be seen in Figures 15, 16, & 17.

Figure 15. Top View of Hole Redesign

Figure 16. Front View of Hole Redesign

Figure 17. Side View of Hole Redesign

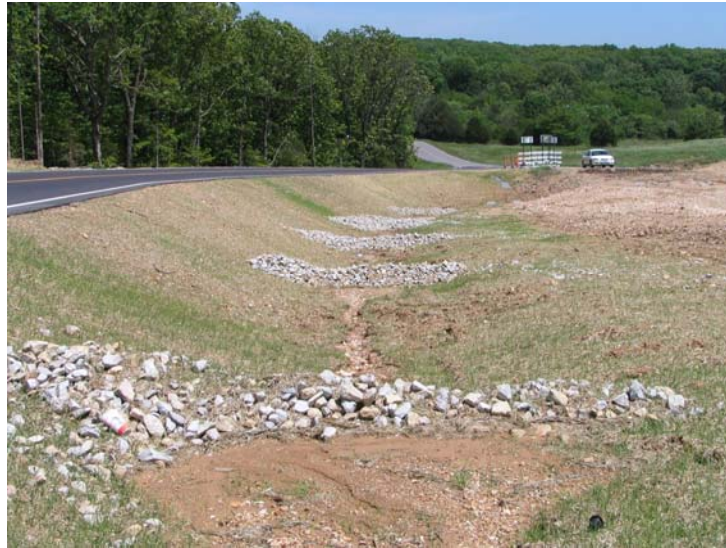
Figure 18. One-Rock Dam

One-rock dams are typically used with channelized waterways or other flow paths where water has the ability to generate speed. This structures success is dependent rock depth in stream.

- Perpendicular to the water flow
- Single stacked rock line
- 6in diameter rocks minimum in front line
- Rock diametyer should gradually increase with each consecutive row.
- Consist of 4 to 6 rows

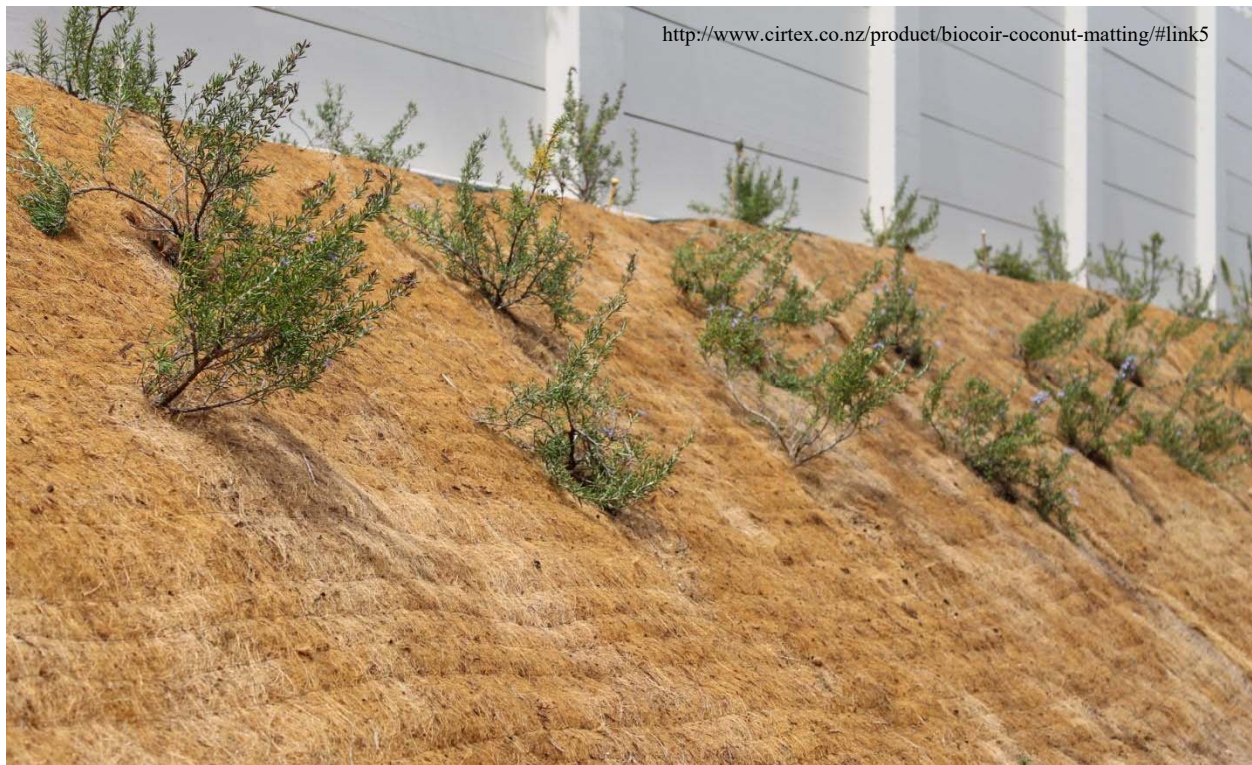
Figure 23. Combination of Live Stakes & Coconut Matting

A combination of these techniques is more realistic for this project. For example, using coconut fiber sheets and live stakes together will be more effective in stabilizing the soil near the stream than using them apart (Figure 23). The coconut fiber mats stabilize the topsoil, while the live stakes develop the soil below. This would be a great application for the main stream that flows throughout Parkview Estates. There are currently tri-lock blocks along a problem area that will be available for improving the soil stability. Planting seeds in between these blocks could be an inexpensive and effective way to reduce erosion at that particular site.

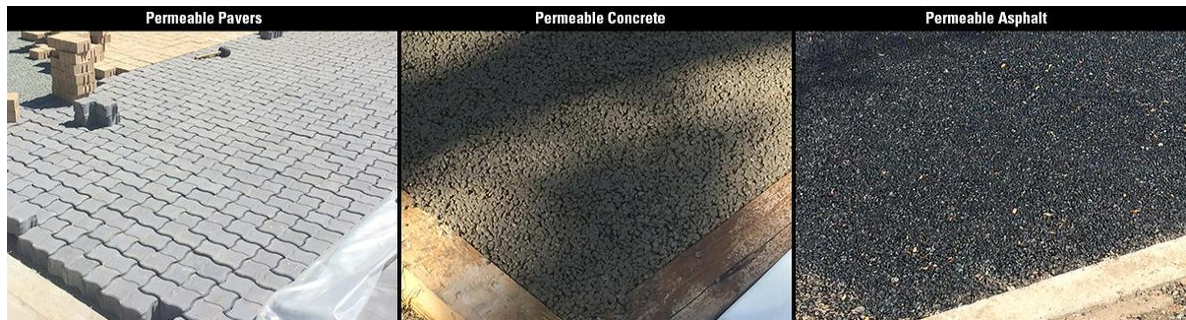
Figure 28. Different Types of Permeable Pavement

Permeable paving is an LID practice that involves paving developed areas with pavement or bricks that are made to be porous, which allows storm water runoff to infiltrate the pavement and reach the soil beneath it. Durability and maintenance are some of the problem factors in this practice. The pavement will need regular cleaning due to sediment clogging the small holes in the pavement which the water passes through. Since permeable pavement is not as strong as regular pavement, durability becomes an issue when the paved area is heavily used. Different types of permeable pavement include asphalt, concrete, and bricks or pavers (Figure 28). The costs of permeable material vary. Asphalt is about \$0.50 - \$1.00 per ft<sup>2</sup>, concrete is about \$2.00 -

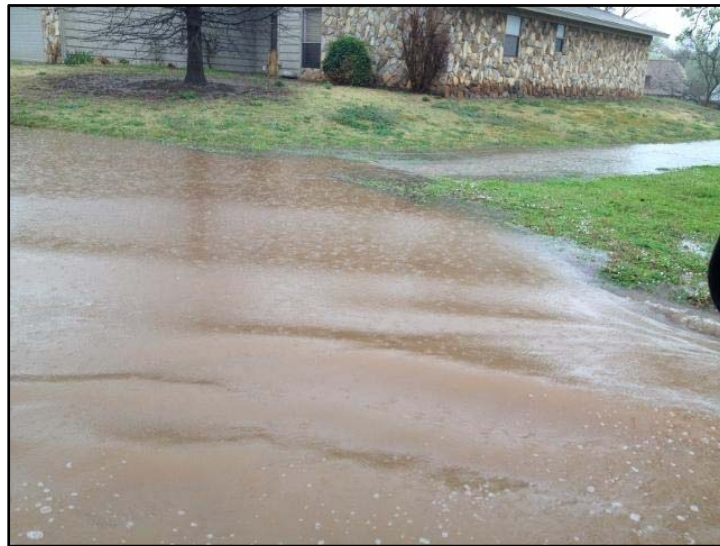
Figure 30. Ponding Observed at Park View Estates

Slope gradation is a practice used to control and direct water flow across or down a slope. Water will naturally flow to the lowest point in a landscape and grading allows for the land to be reformed and the drainage patterns controlled (Matusik and Deible, 1996). Controlling the drainage is important for the preservation of structures as well as landscape. Allowing the water to drain too quickly can result in erosion. Conversely, draining too slowly causes ponding, which can also be destructive in a landscape, as seen at Parkview Estates in Figure 30 (Mihalic, 2014).

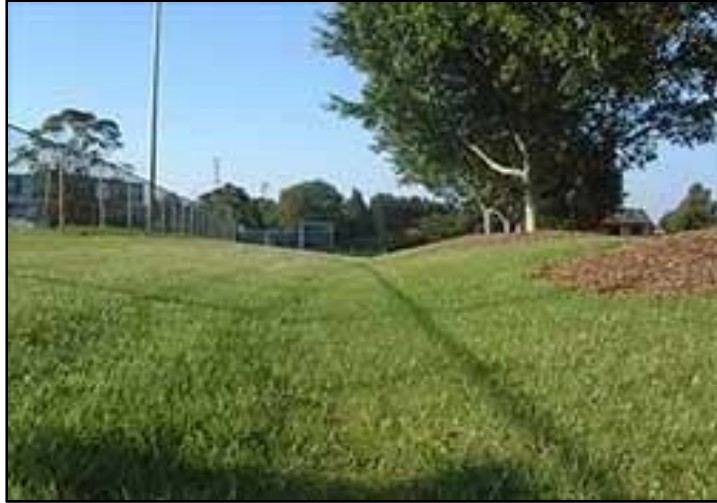
Figure 31. Simple Grass Swale

plans. This is a point in the process where swales or drains can be added to aid in drainage. A swale, in its most simple form, is a crease in a slope where water can gather to drain to lower ground, as seen in Figure 31. Swales do not have to be simple, however. They can be expressed in many functional, and aesthetically pleasing, ways according to Mihalic, such as filling them with plants, stones, making them curvy to mimic creeks and river beds, or any combination of the three.

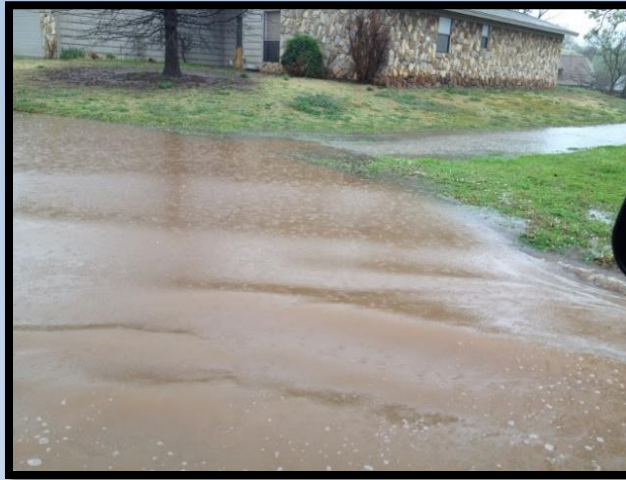
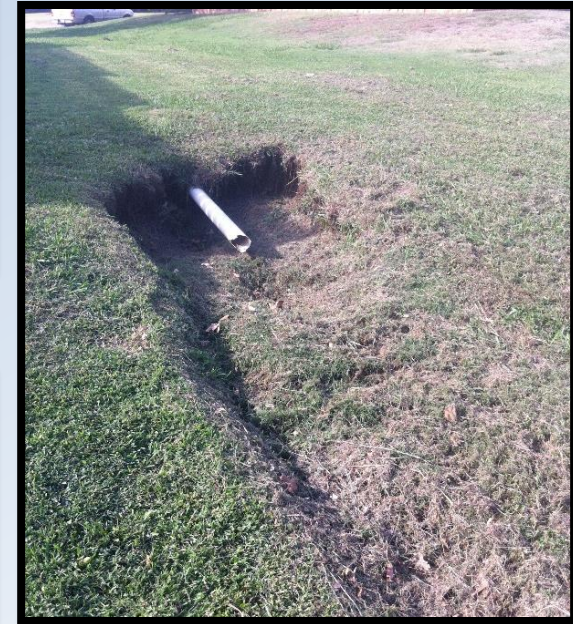
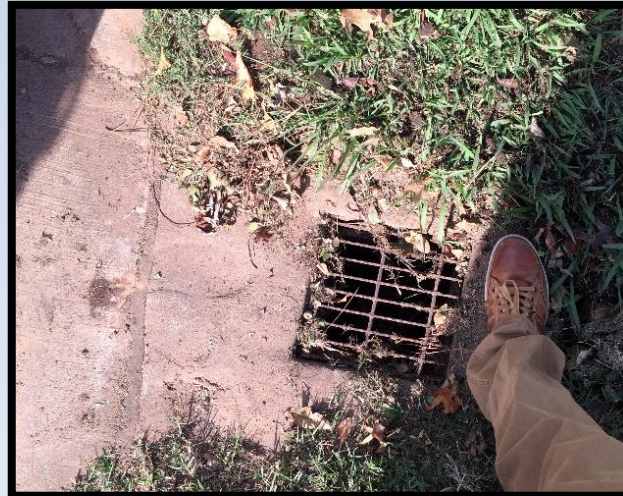
- Ponded water in cul-de-sac 48 hours after storm event
- Under designed drain pipe
- Erosion at drainpipe outlet & at tree stump

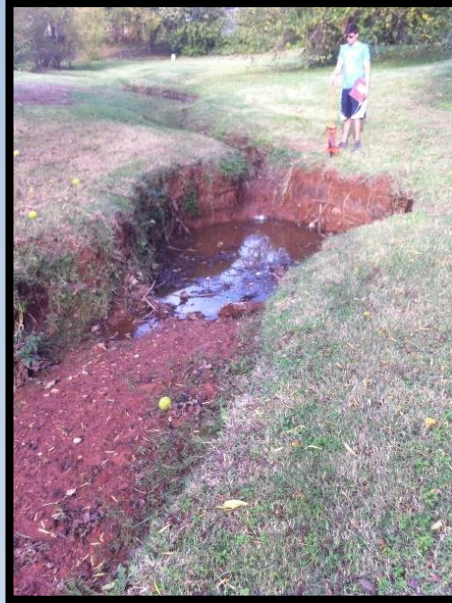
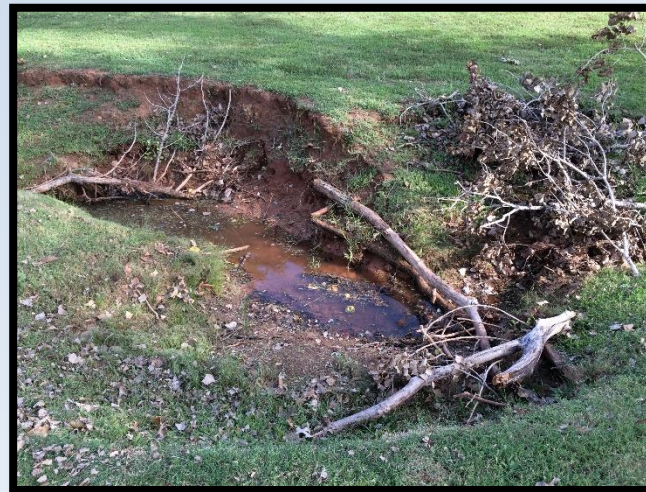
- Massive holes forming throughout stream
- Streambank erosion
- Sediment transport
- Sediment deposition

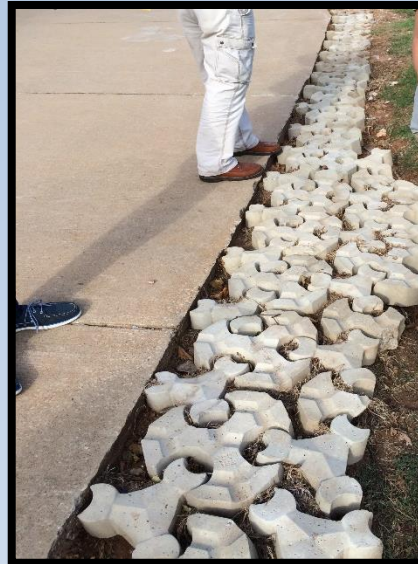
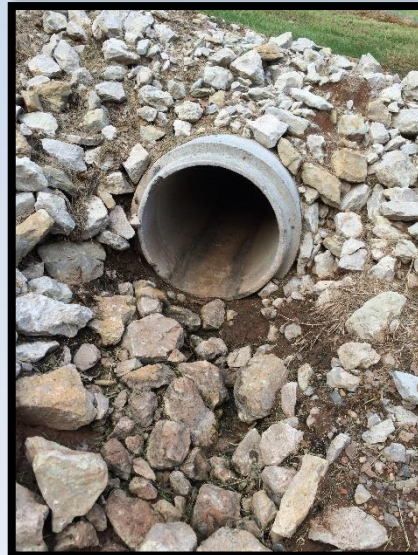
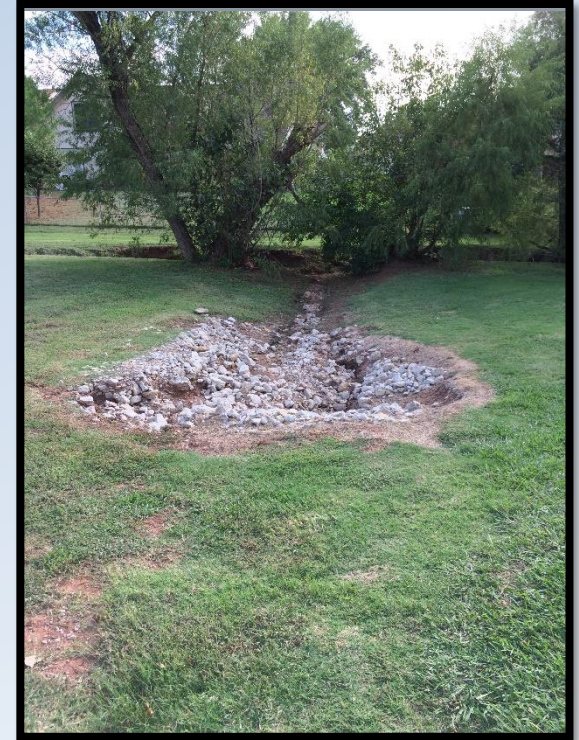
- Erosion along left side of pool driveway
- Washout of riprap at culvert outlet
- Excessive energy at culvert outlet

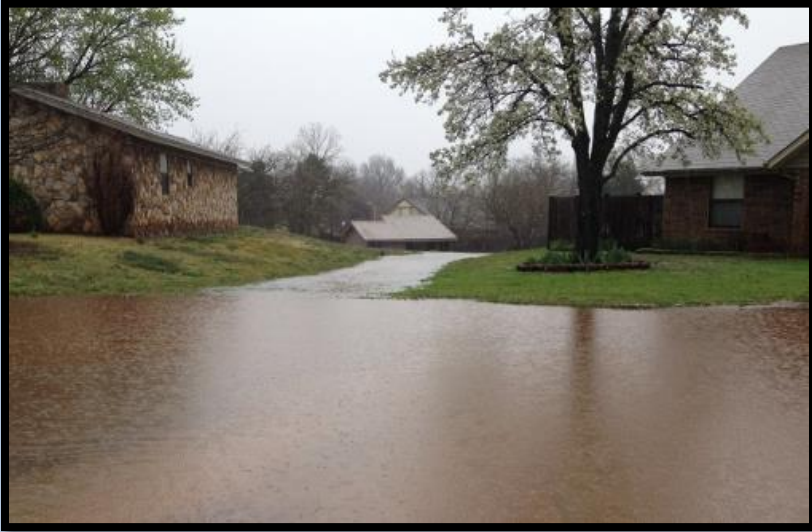
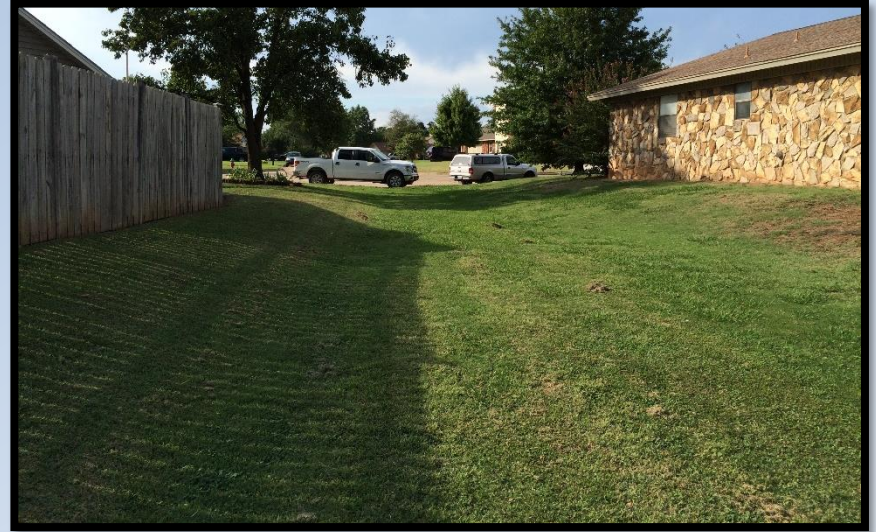
# Regrading Slope

- The poor slope is the main cause of flooding in cul-de-sac
- Regrading will eliminate future flooding
- Average cost of grading: \$0.59 / sq. ft

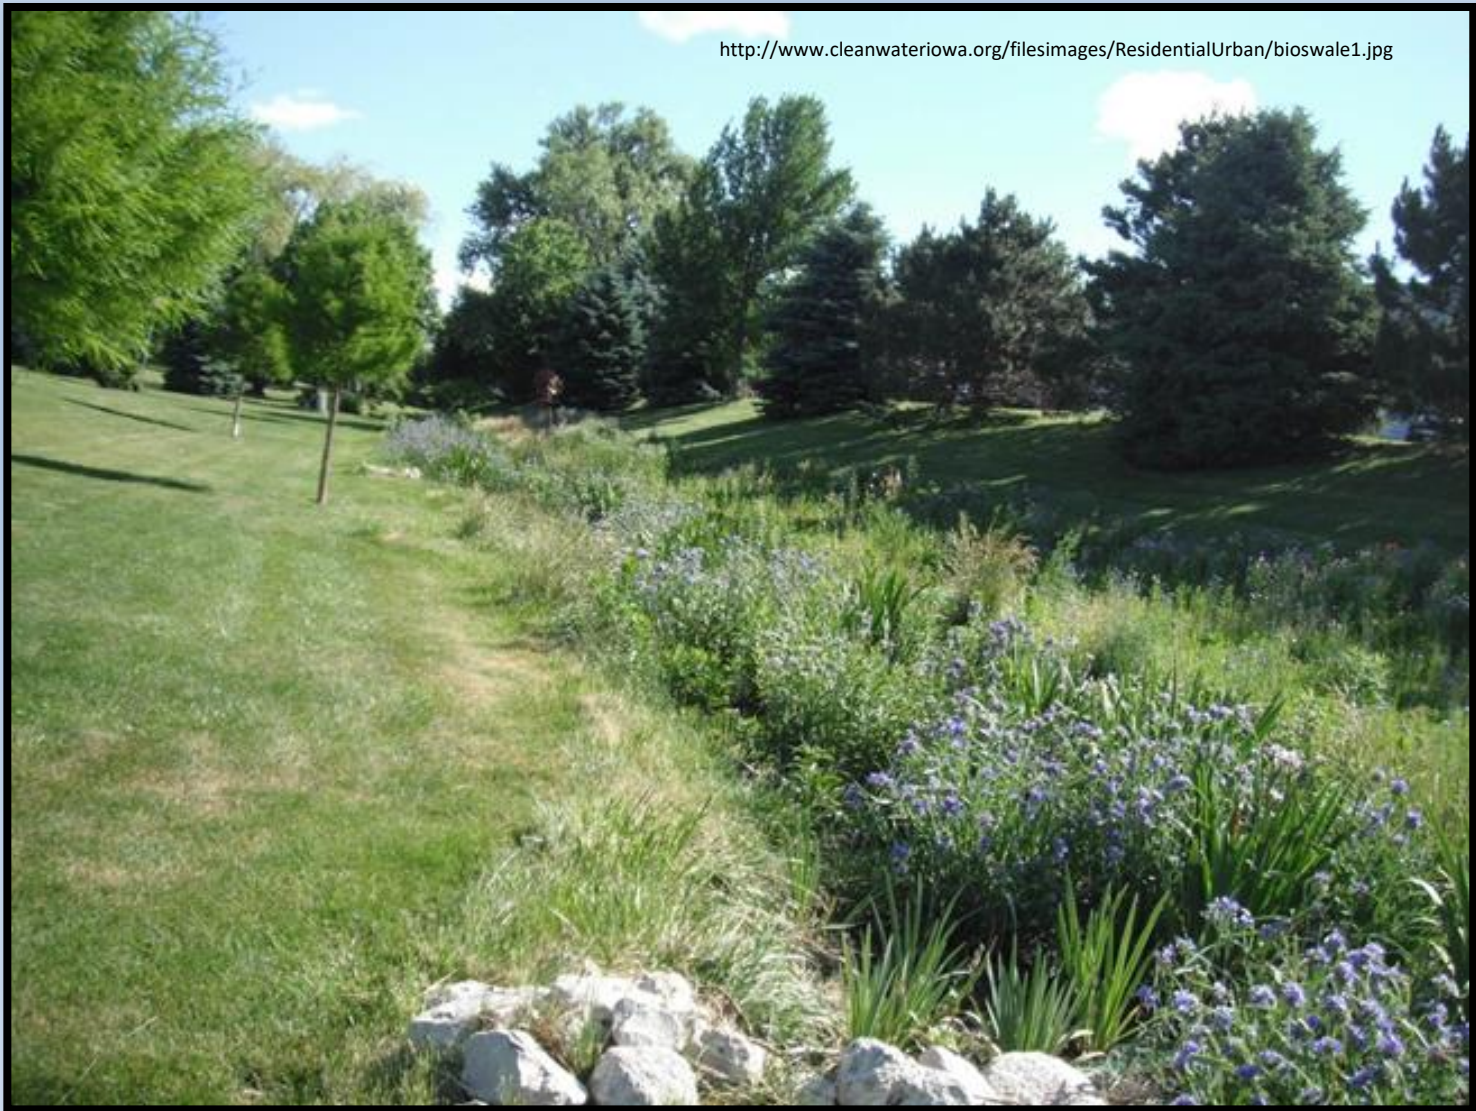
- Curb and Pathway
  - Redo slope grading
  - Remove pipe
  - Implement permeable walkway
  - Install multiple small bioretention cells
- Greenbelt Area
  - Construct complete bioswale
  - Add check dams
  - Input aesthetic vegetation along swale

**Example of High Cost Residential Bioswale**

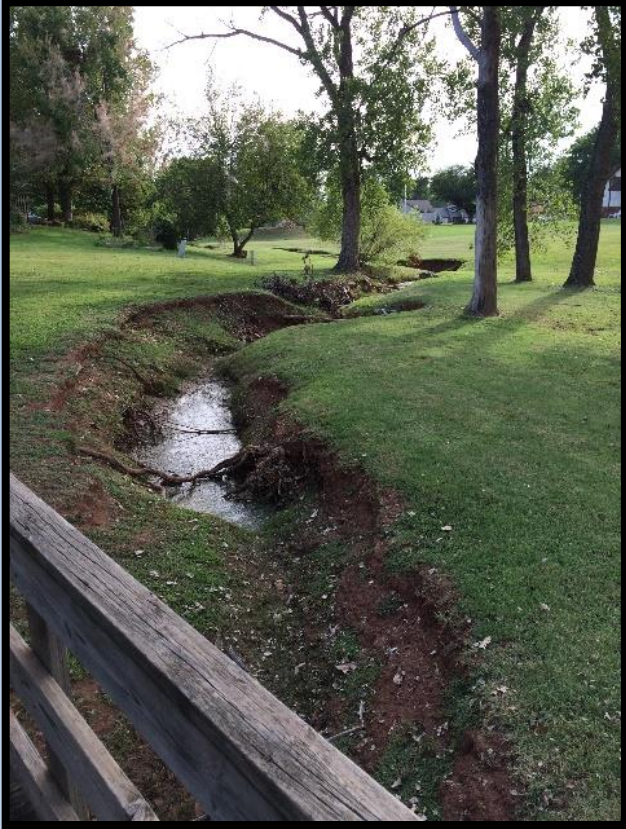
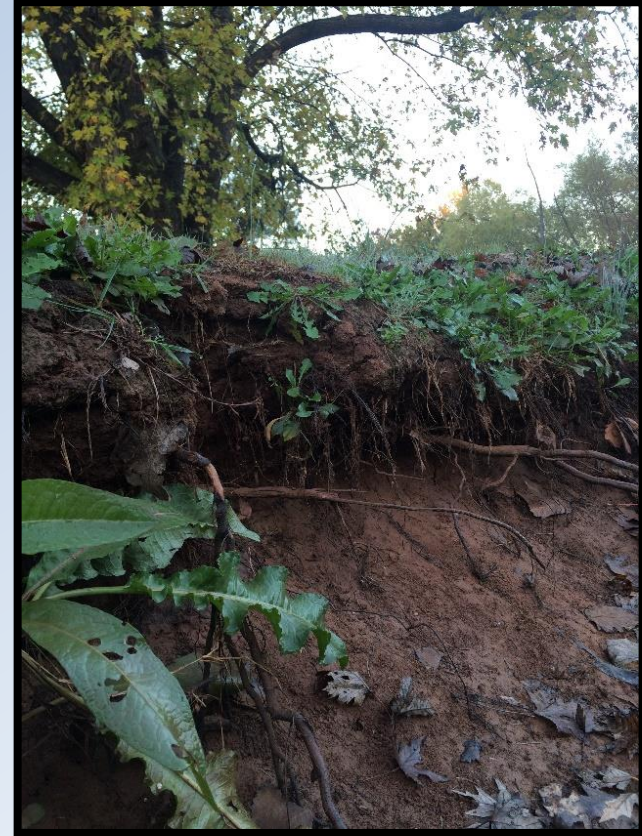
- Streambank erosion
- Vertical banks
- Large pooling
- Sediment build up

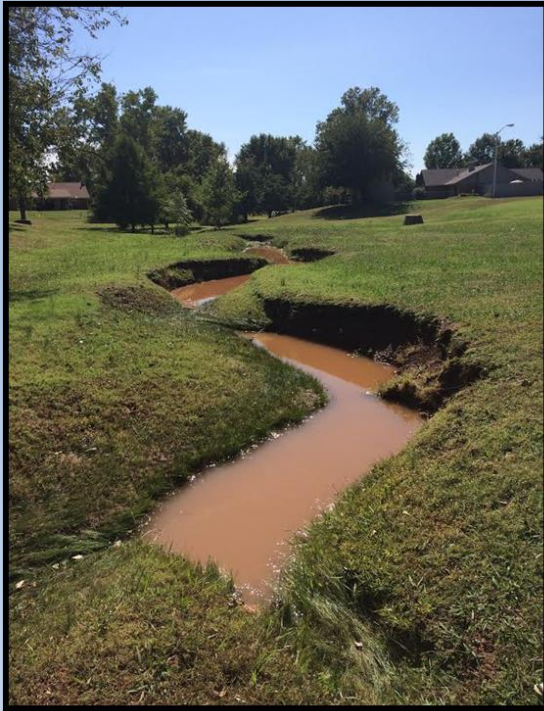
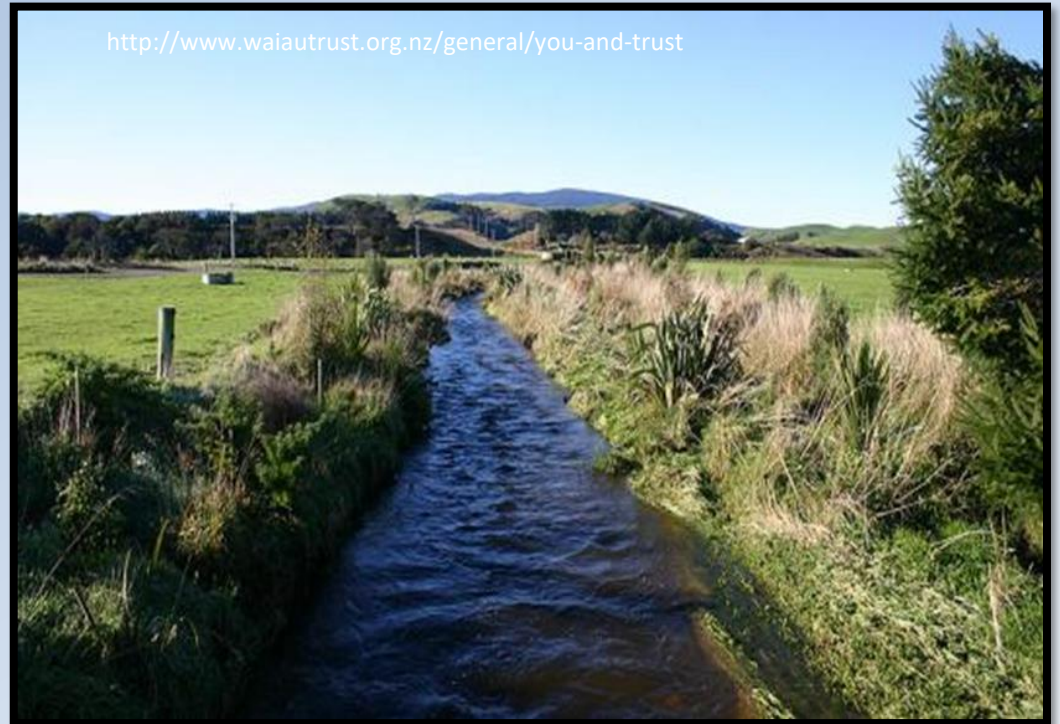
- Roots from vegetation provide an anchor for the stream bank soil
- Provides an ecosystem for small animals and insects that help stream stability
- Inexpensive way to help prevent stream bank erosion

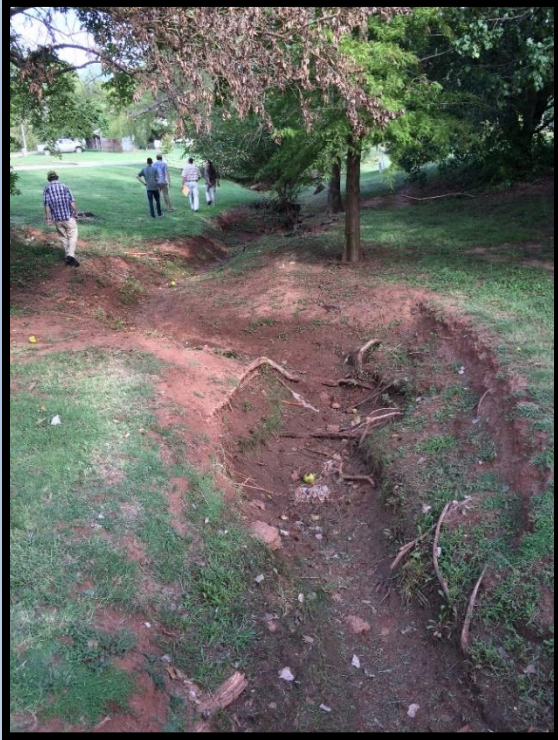
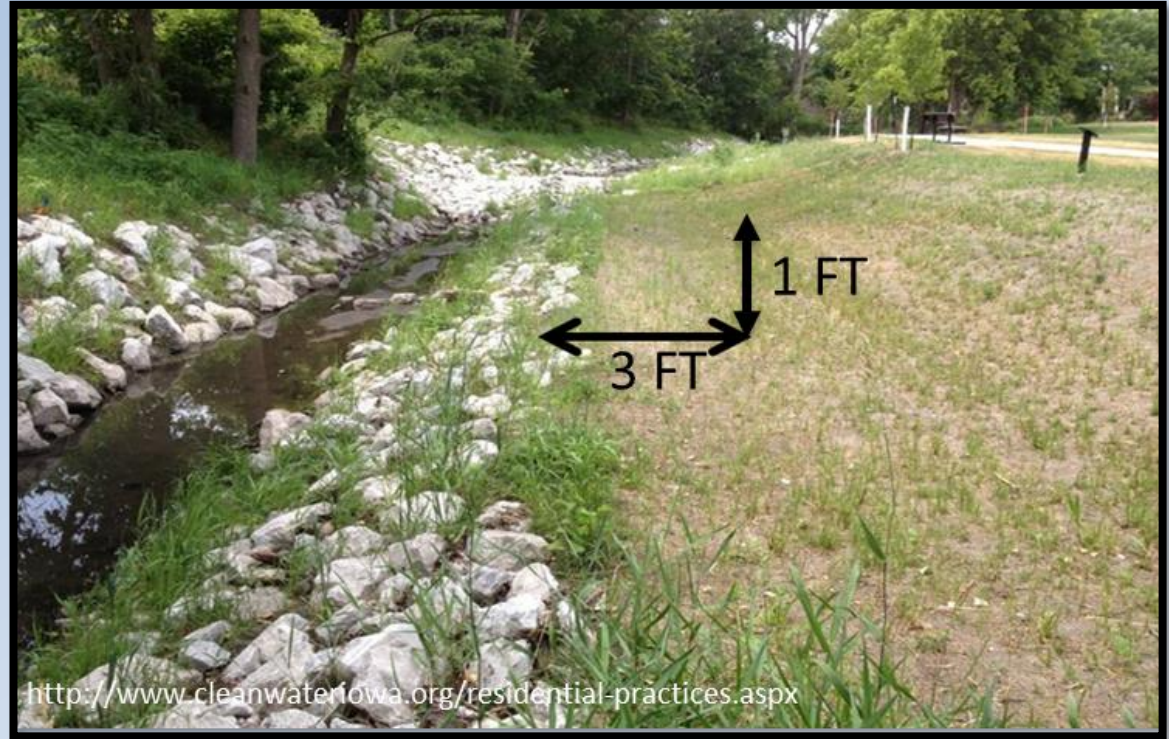
- Riprap prevents erosion by providing armor for the streambank soil
- Vegetation can grow in between the stones, benefiting the riparian zone
- Natural appearance

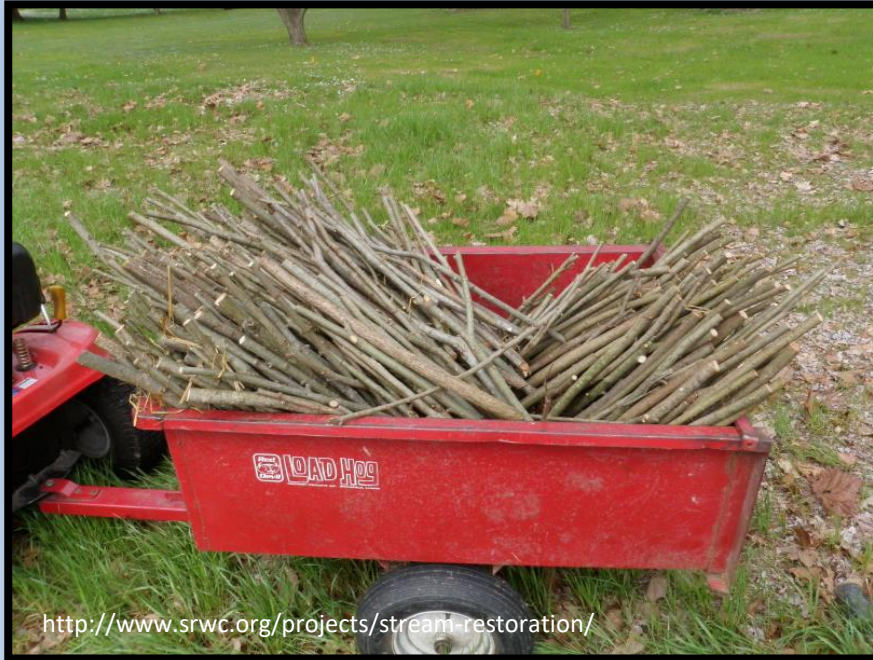
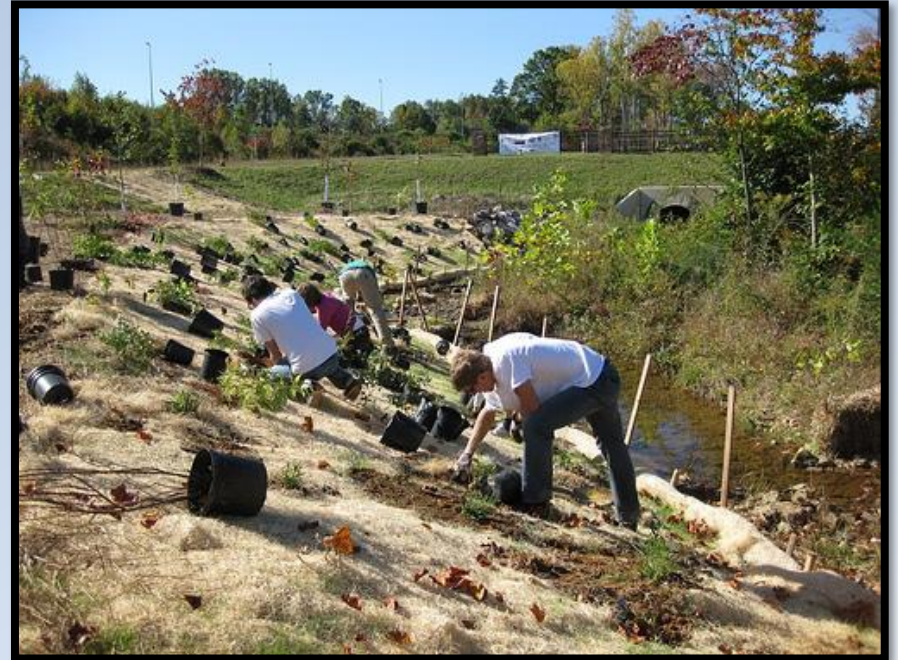
- “Live stakes” are small woody cuttings of indigenous trees or shrubs that can easily be replanted into the stream bank
- Implementing vegetation that is indigenous to the area provides stability, biofiltration, and natural aesthetics

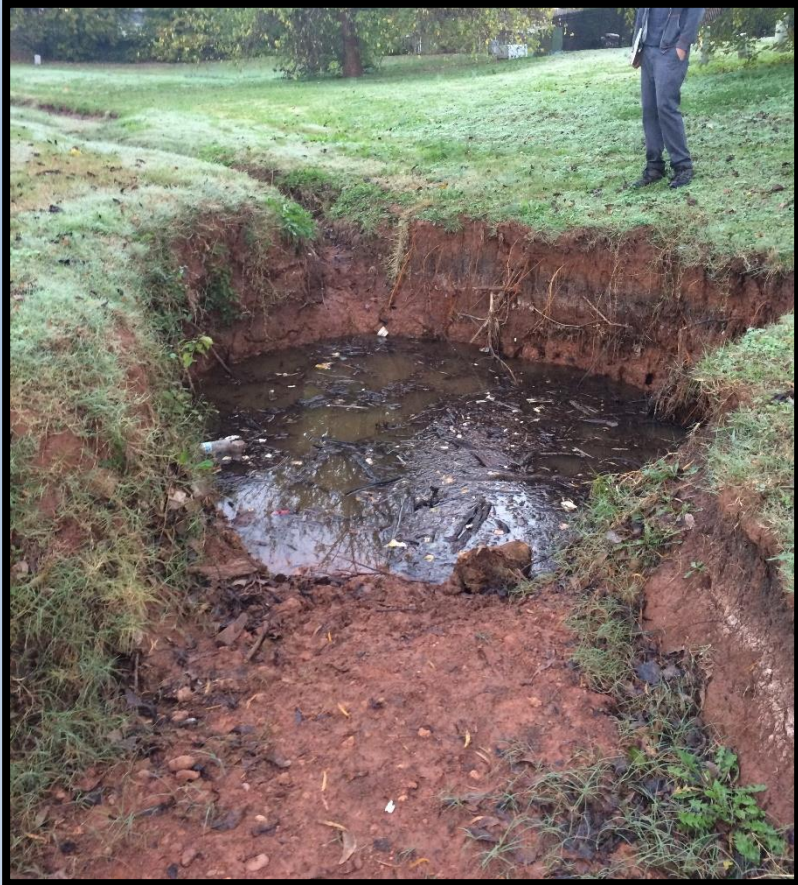
- Implement “No Mow” riparian buffer zone
- Regrade high priority sites
- After regrading apply turf and coir matting

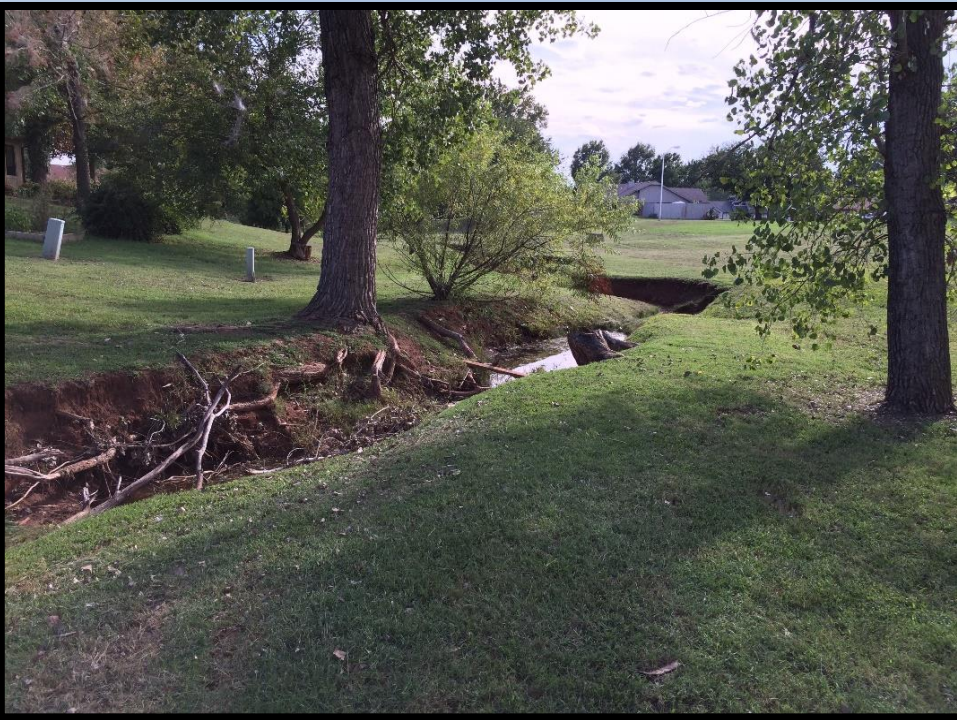
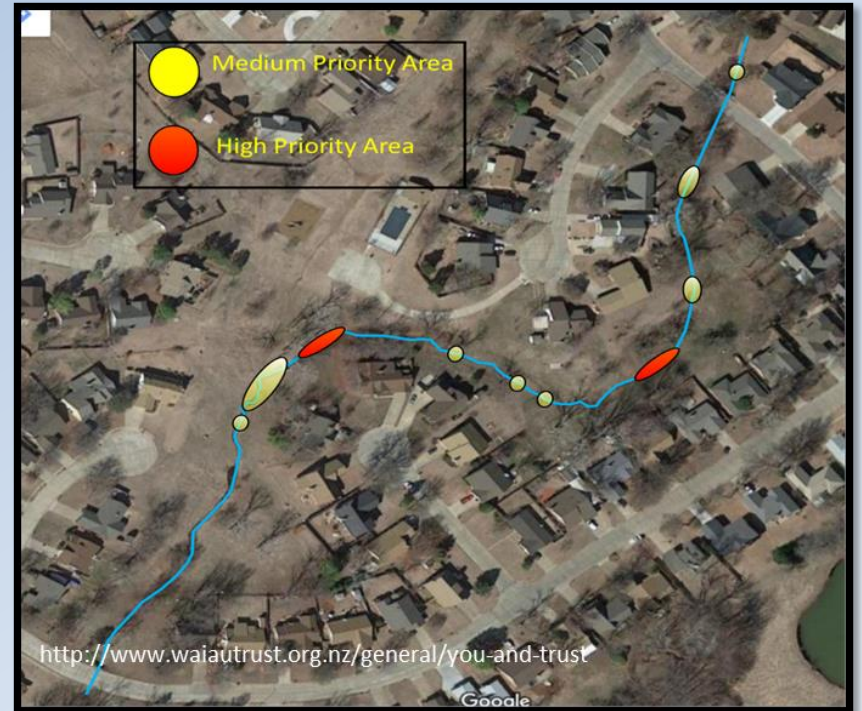
- Build on low cost solutions
- Regrade the medium priority sites along with the high priority sites
- After regrading, apply turf and coir matting

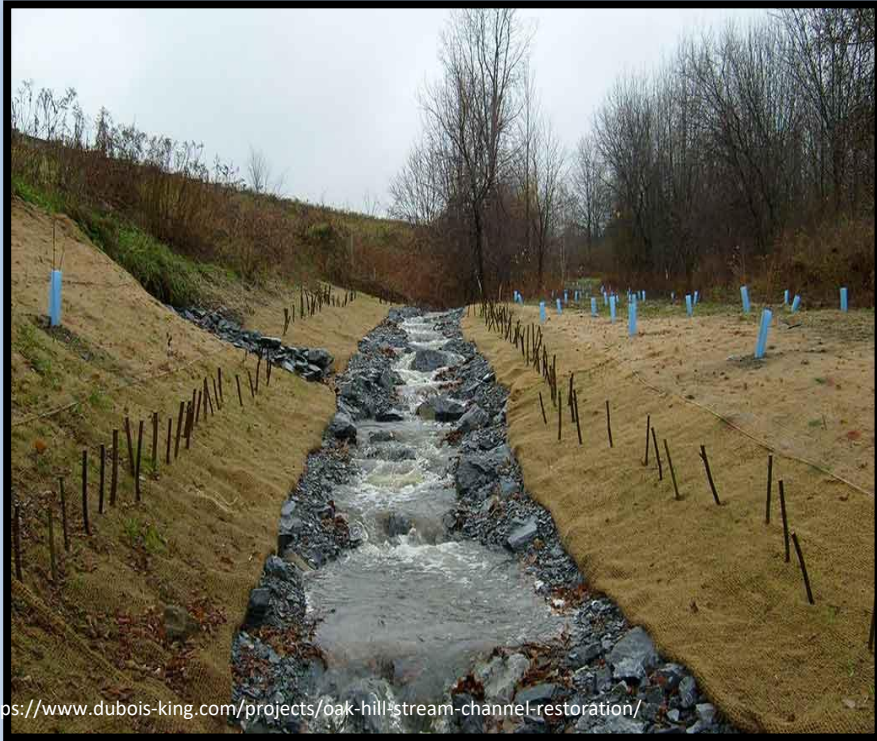
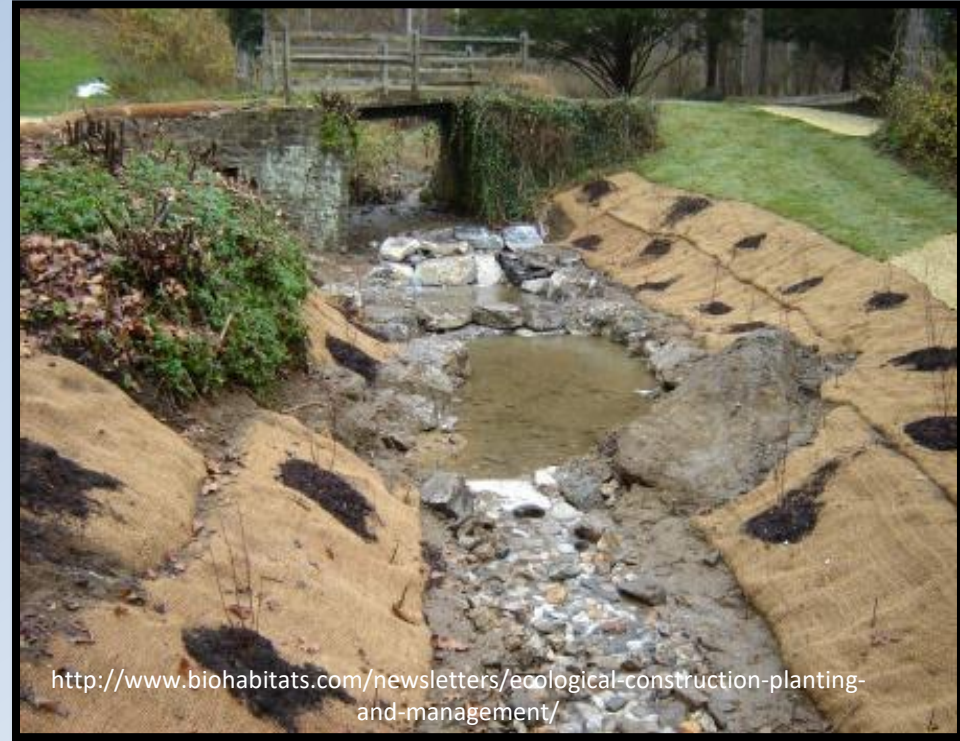
- Build on low and medium cost solutions
- Plant live stakes and other native vegetation
- Incorporate all possible solutions into one total stream reconstruction design

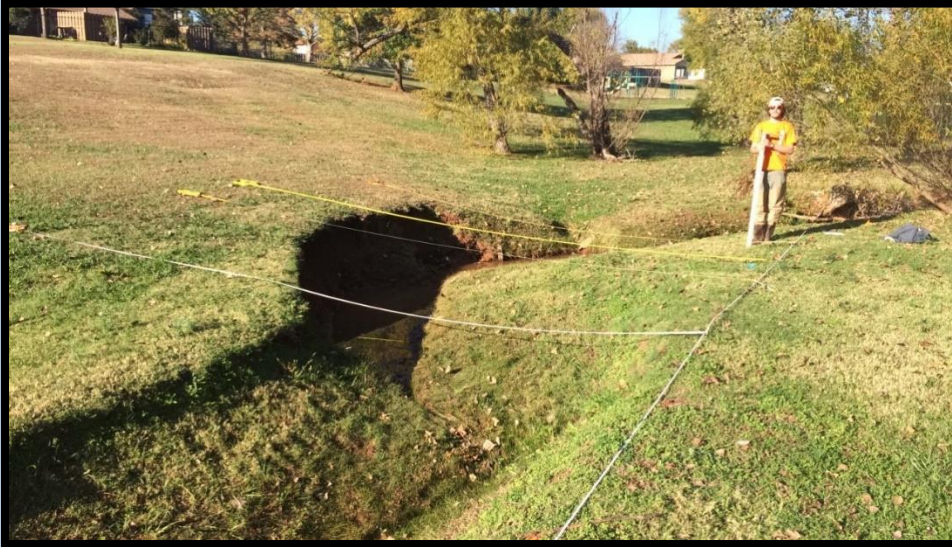
- Cross section surveys were conducted
- Survey data will allow us to determine priority sites, stream profiles, and bank slopes ratios
- These parameters will be used to assess stream bank erosion and the best restoration practice to be applied

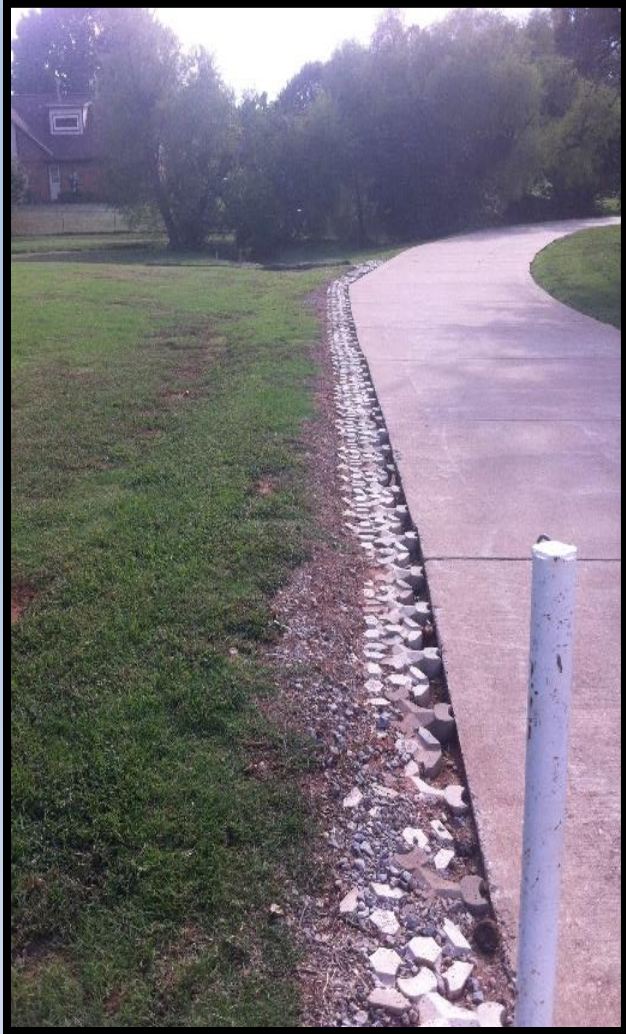
Erosion along  
walkway from cul-  
de-sac to pool area

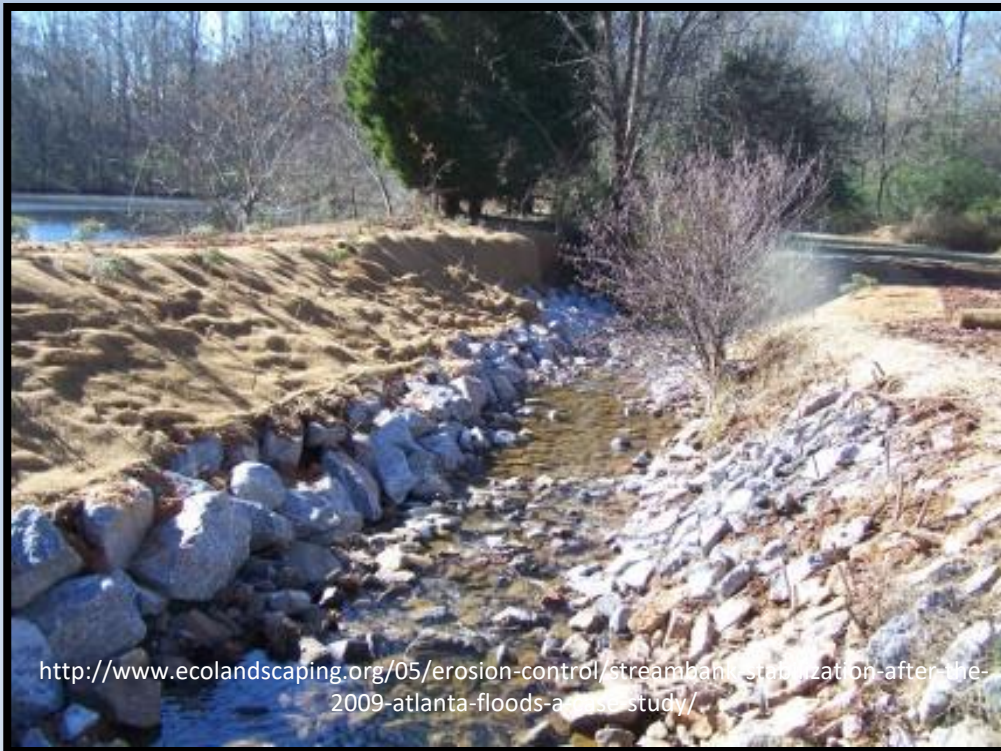
- Pros
  - Breakup of runoff energy
  - Armoring for soil
- Cons
  - Expensive
  - Can cause potential downcutting and scouring
