# COWBOY STORMWATER MANAGEMENT

## Senior Design Spring 2017 Report

May 4th, 2017

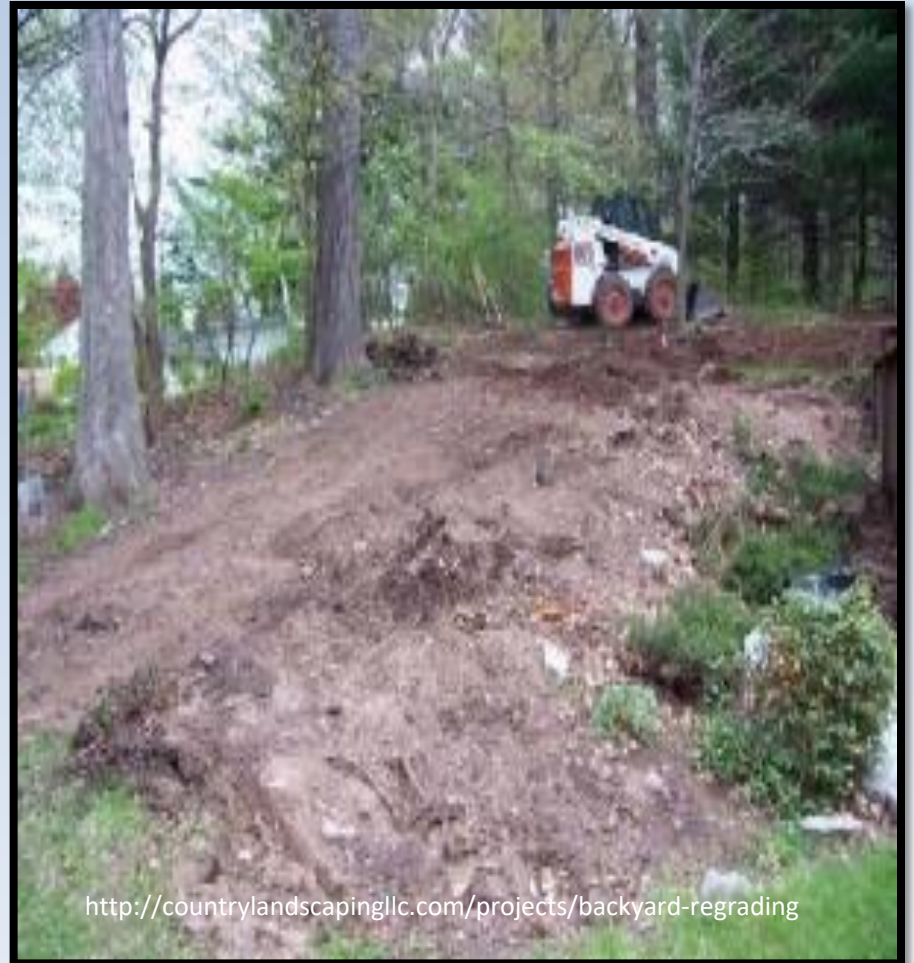
- Pros
  - Better slope
  - More secure soil
- Cons
  - Initial maintenance

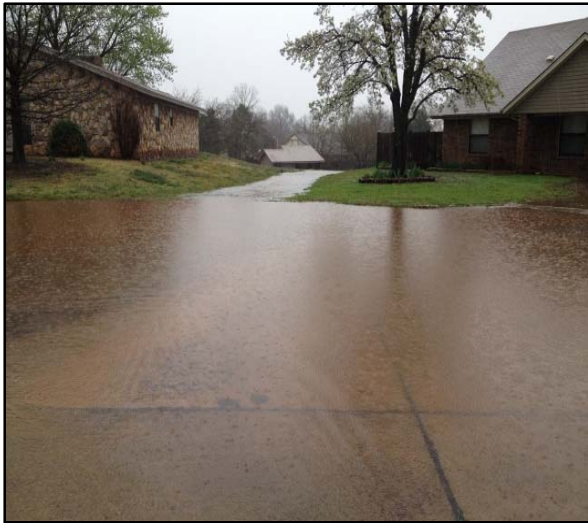
Figure 2. Flooding and Ponding During Storm Event

Due to runoff from impermeable surfaces and an undersized drain, the area near 304 E Marie drive is experiencing flooding and ponding during storm events, as seen in Figure 2. The impermeable streets and driveways are not allowing for any infiltration. This creates a high volume of runoff directed to a drain that is under designed for the drainage area. The undersized drain results in overflow, causing ponding and erosion down the slope toward the stream.

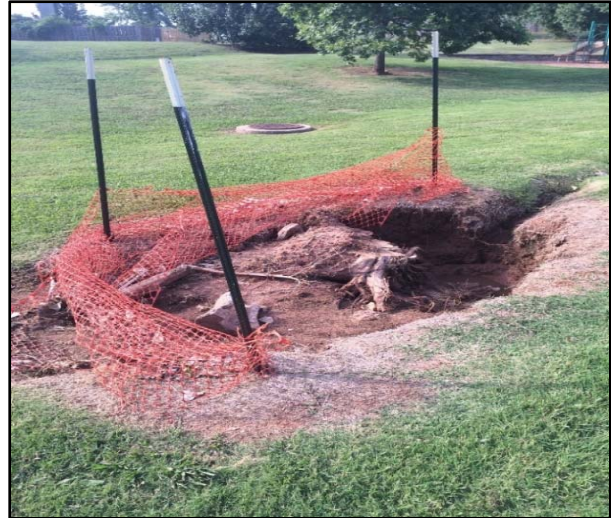
Figure 3. Example of Erosion in Greenbelt Area

The greenbelt area for this job site is defined as the area between the cul-de-sac drainage areas and the stream. There are several small, but severe, problem sites in the greenbelt. The outlet for the drain from 304 E Marie has experienced erosion causing a large hole. Also, in Figure 3 below, the area around the stump has been heavily eroded causing a large hole that has potential safety hazards for residents.

The greenbelt area contains several places where high velocity stormwater has cut deep holes in the waterway (Figure 3). The low cost solution requires that these individual sites be excavated, regraded, and covered with turf. Other areas along the greenbelt space may also require regrading. Ideally, stormwater runoff volume and velocity would be reduced, however, regrading key areas instead of implementing LID practices will reduce cost and still meet customer requirements.

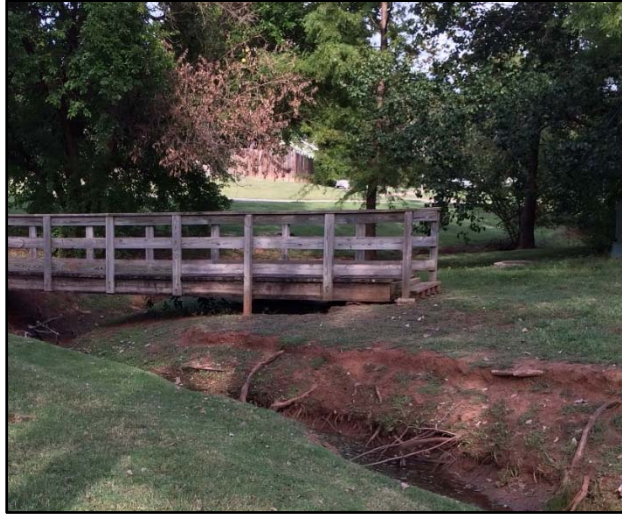
Figure 4. Erosion near Walking Bridge

With the large amount of runoff mentioned above, all of the water is being guided directly to the stream leading to erosion along the stream banks, as seen in Figure 4 below. The erosion is responsible for several problems, such as large pools in the stream and sediment deposits, as well as sediment transport to Boomer Lake

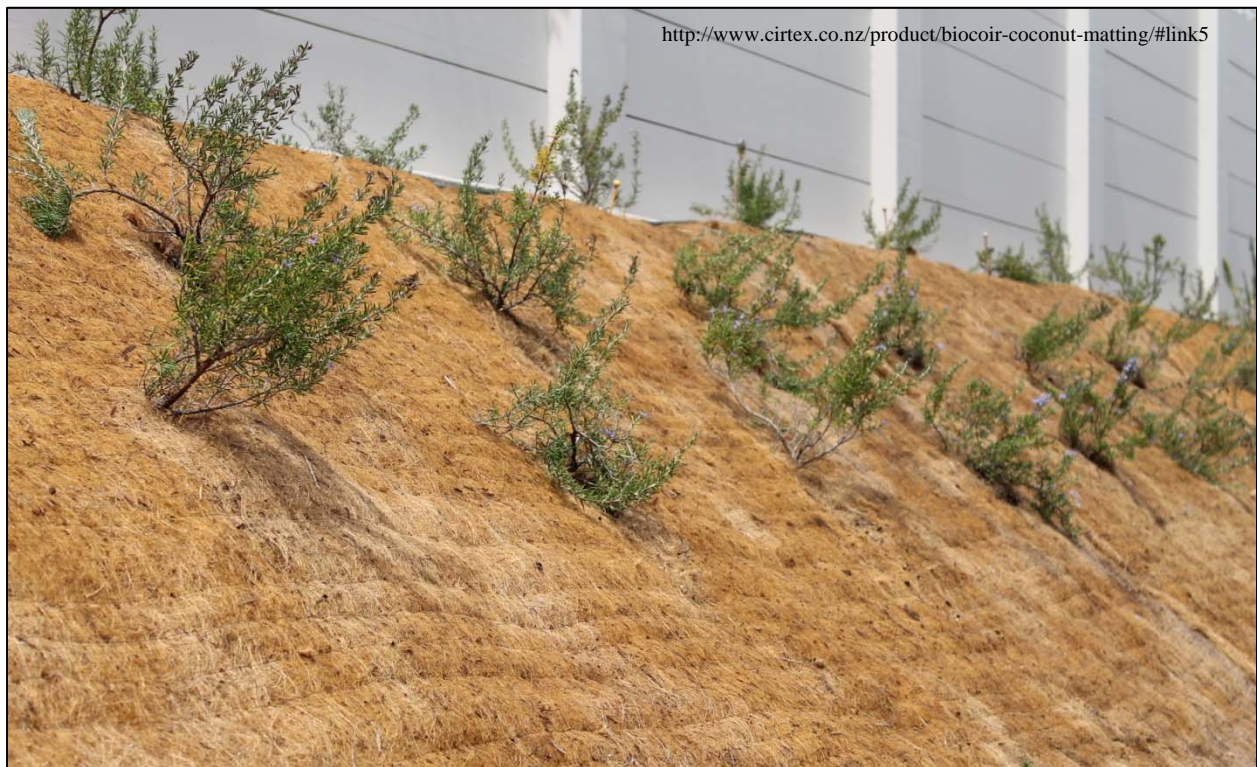
Figure 7. Combination of Live Stakes & Coconut Matting

A combination of these techniques is more realistic for this project. For example, using coconut fiber sheets and live stakes together will be more effective in stabilizing the soil near the stream than using them apart (Figure 7). The coconut fiber mats stabilize the top soil, while the live stakes develop the soil below. This would be a great application for the main stream that flows throughout Parkview Estates. There are currently tri-lock blocks along a problem area that will be available for improving the soil stability. Planting seeds in between these blocks could be an inexpensive and effective way to reduce erosion at that particular site.

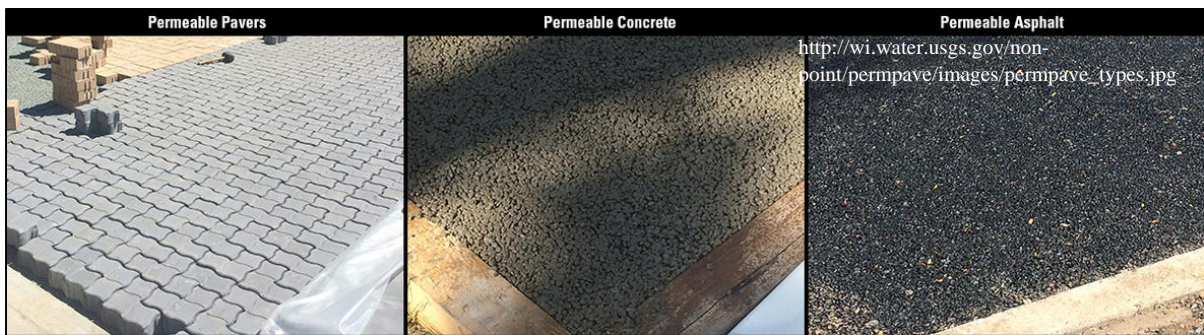
Figure 11. Different Types of Permeable Pavement

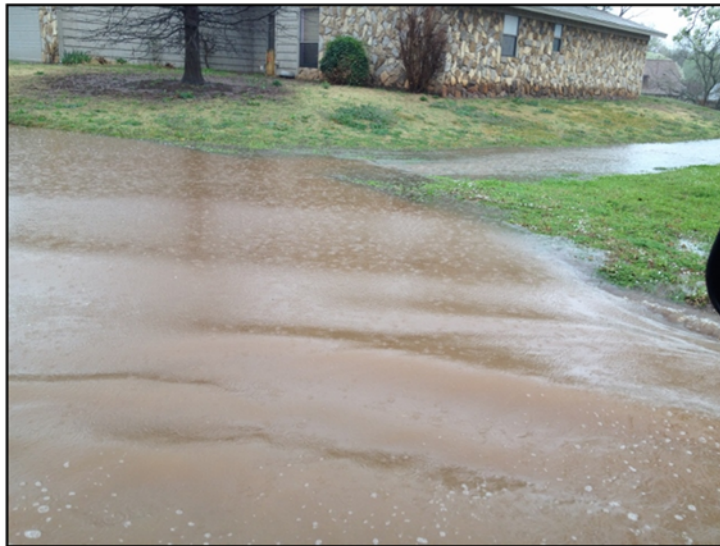
Figure 13. Ponding Observed at Park View Estates

Slope gradation is a practice used to control and direct water flow across or down a slope. Water will naturally flow to the lowest point in a landscape and grading allows for the land to be reformed and the drainage patterns controlled (Matusik and Deible, 1996). Controlling the drainage is important for the preservation of structures as well as landscape. Allowing the water to drain too quickly can result in erosion. Conversely, draining too slowly causes ponding, which can also be destructive in a landscape, as seen at Parkview Estates in Figure 13 (Mihalic, 2014).

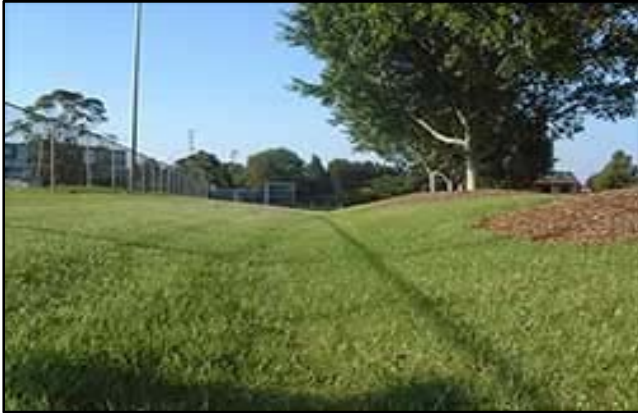
Figure 14. Simple Grass Swale

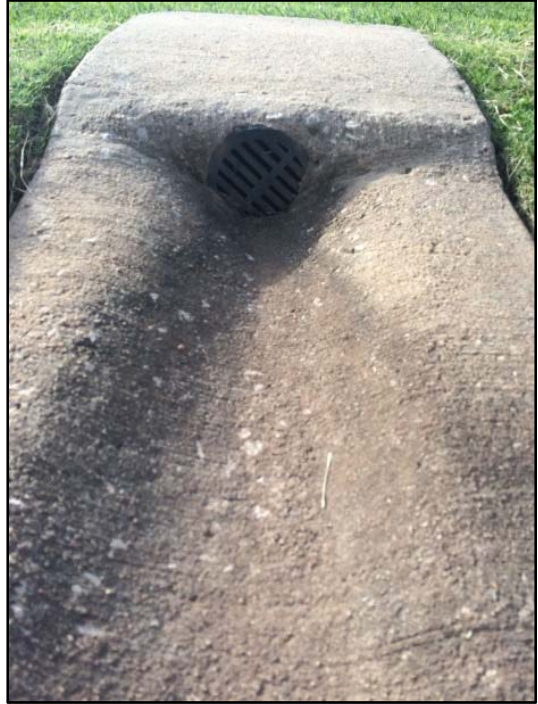
Figure 15. Undersized Drain at Park View Estates

Slope grading will be a very useful technique to use in the issues in Parkview Estates, more specifically in the area beside 304 Marie Drive house leading into the creek area behind all the houses. With the undersized drain, as seen in Figure 15, and slope down to the creek, the water is not being directed correctly and causing erosion problems as well as ponding issues. Grading the hillsides of the property into a natural swale to direct the water seamlessly down to the creek bed will cut down on ponding and provide a natural looking solution. It will also cut down on the erosion issues such as the pipe blowout in Figure 16.

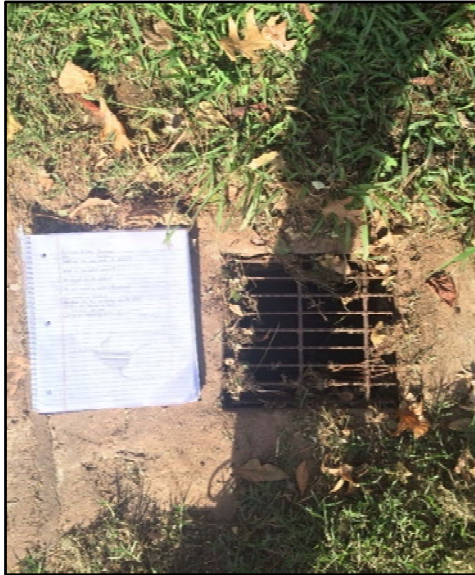
The low cost solution for this site is to remove the undersized drain (Figure 19), along with the drainage pipe (Figure 20), and then re-grade the grass swale to a more optimal downhill slope for draining the stormwater. Sod would then be implemented onto the top of the regraded area. Some survey work of the grass swale has been conducted but more work is necessary. With complete data, CSM can create a model of the cross sections and slope of the swale and hill to begin the re-design.

Figure 19. Undersized storm drain located at Site A    Figure 20. Drainage pipe located at Site A

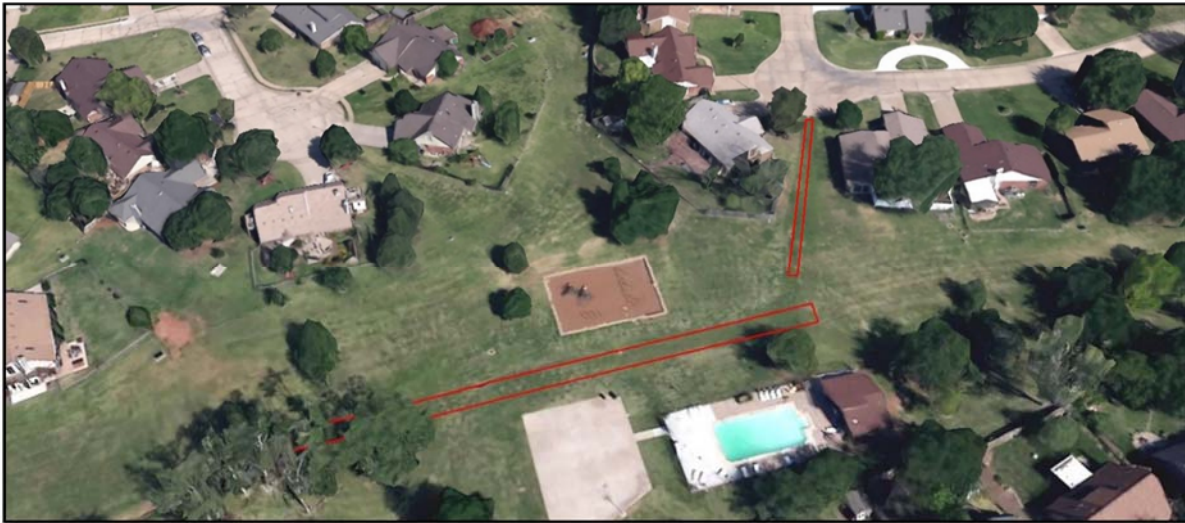
Figure 21. Location of Bioswale and Permeable Pavement at Problem Site A

In addition to removing the eroded sites, a bioswale would be implemented along the greenbelt area (Figure 21). The bioswale would be graded to at least a 7:1 (horizontal:vertical) slope that is suitable for easy access and maintenance such as mowing. The top layer of the swale would incorporate grass/sod as a vegetative buffer that would slow water velocity, thereby increasing infiltration. The bioswale would be a natural looking solution that guides stormwater to the stream and reduces stormwater runoff.

The medium cost solution for the cul-de-sac area includes everything that the low cost solution did with some extra features. In addition to regrading the area where the water enters the greenbelt space, permeable pavers would be incorporated as a walkway to the public area. The size of the walkway depends of the budget of the HOA. The permeable pavers would help in two ways. It would improve the aesthetics of that area as well as increase water infiltration. The water that infiltrates between the bricks would mean less water that enters the stream. This could potentially improve Problem Site B as well as Problem Site A.

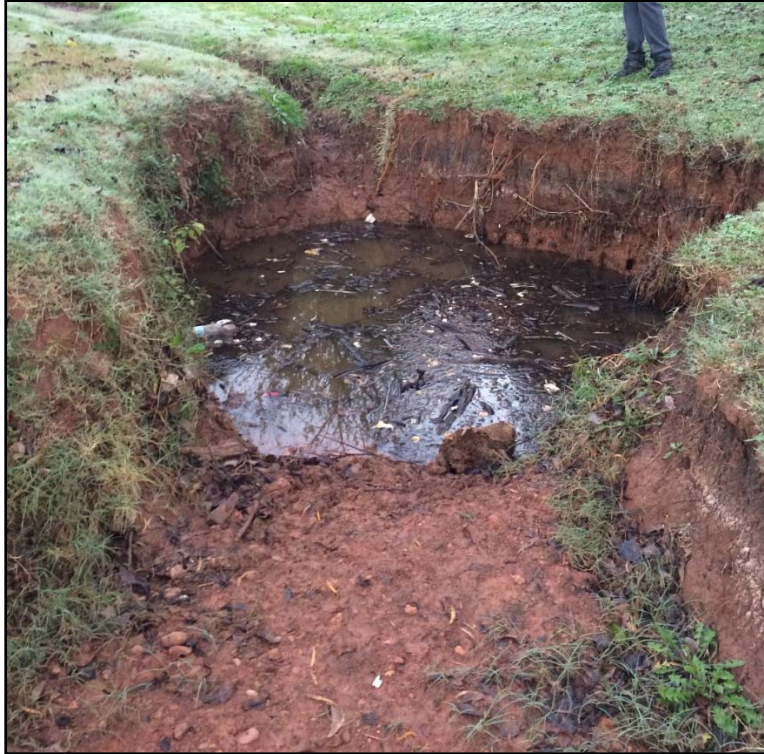
Figure 23. Example of Erosion Occurring at Site B

Streambank erosion is occurring along the entirety of the stream located at Site B. This erosion is caused by the high volume and velocity of the stormwater flowing through the stream. The erosion has caused large pools and sediment barges to form, which are detrimental to the overall stability, flow, and aesthetic functions of the stream. An example of the stream erosion can be seen in Figure 23.

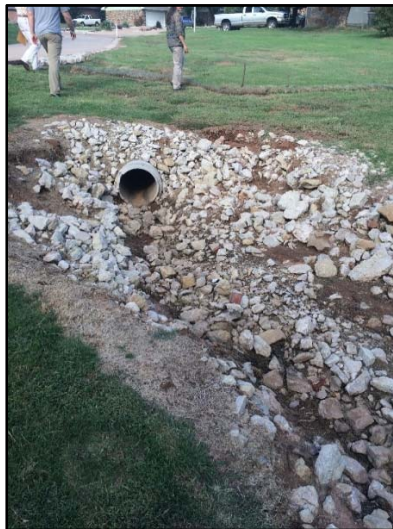
Figure 26. Erosion Occurring at Storm Culvert Outlet Located at Site C

Soil erosion is occurring along the pool driveway entrance, and also at the storm culvert outlet located at Site C (Figure 26). This erosion is caused by excessive stormwater runoff from the North Williams Drive cul-de-sac.

The medium cost solution for the erosion occurring at the pool driveway entrance is implementing more soil and vegetation along the edge of the driveway (Figure 27). Current “tri-lock” erosion management practices will be left there. The erosion at the storm culvert outlet will be addressed by surveying the outlet, excavating the soil, and re-designing the outlet to create stable slopes and a flood plain for the water to spread out and slow down.

The high cost solution builds off the medium solution. CSM would replace the railroad ties that had been previously implemented and still introduce vegetation up to the edge of the ties. The outlet will be re-graded as mentioned above and larger riprap will be implemented at the outlet so the velocity of water flowing into the stream at Site B will be reduced.
